MARINA ADVISORY COMMITTEE

February 26, 2024 at 2pm

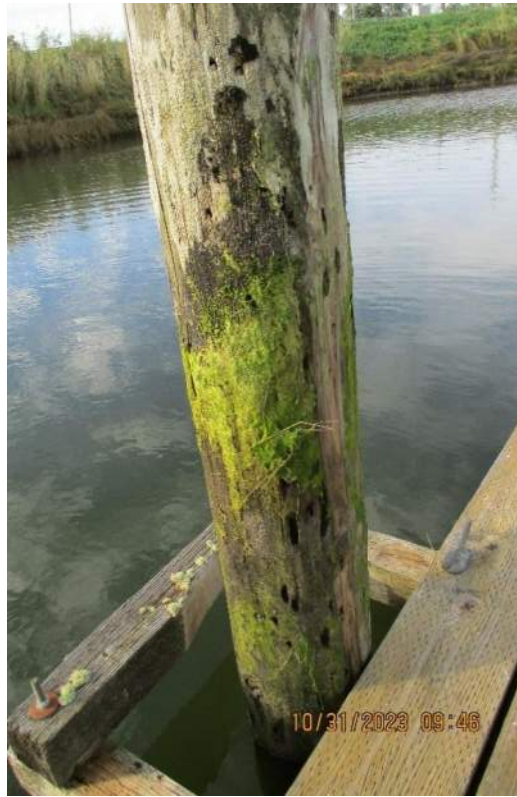
Photo 1:
Typical condition of timber piling. Note marine growth near the waterline.

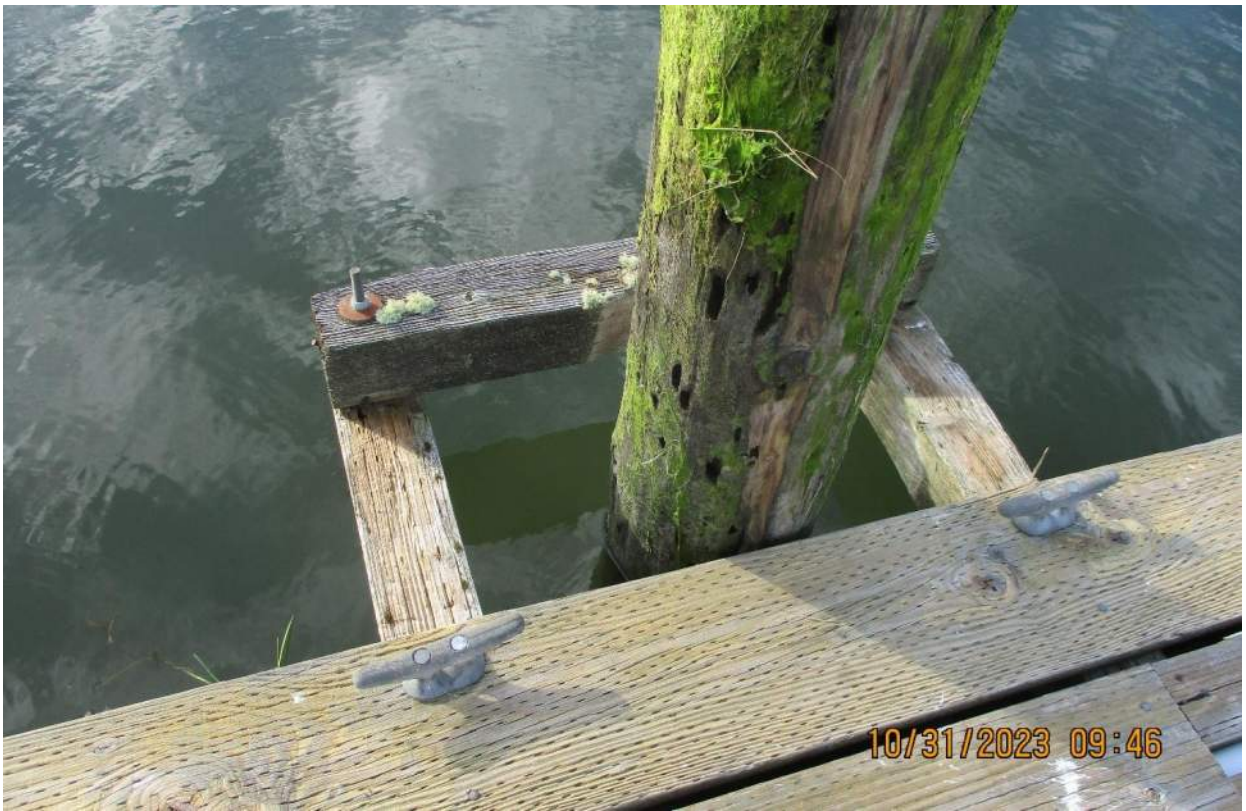
Photo 2:
Close up showing possible marine borer activity.

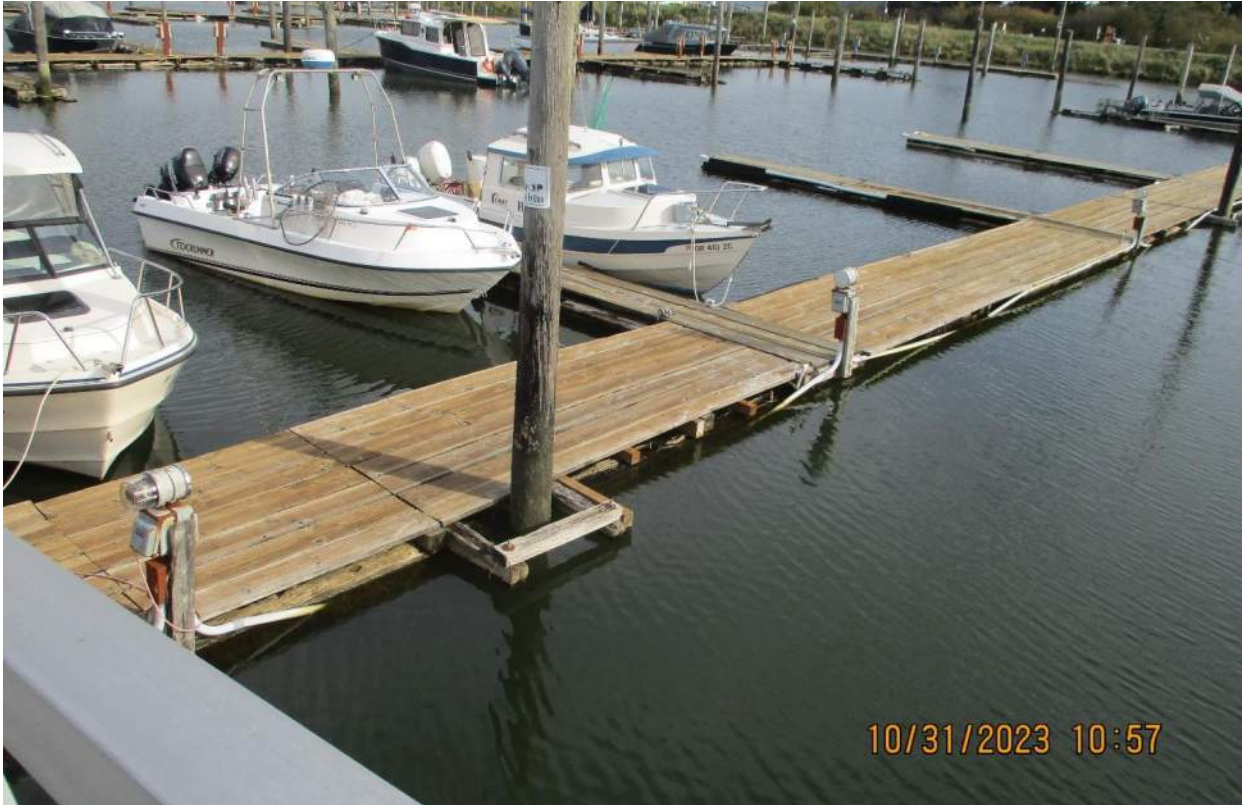
Photo 4:
Typical wooden pile hoop.

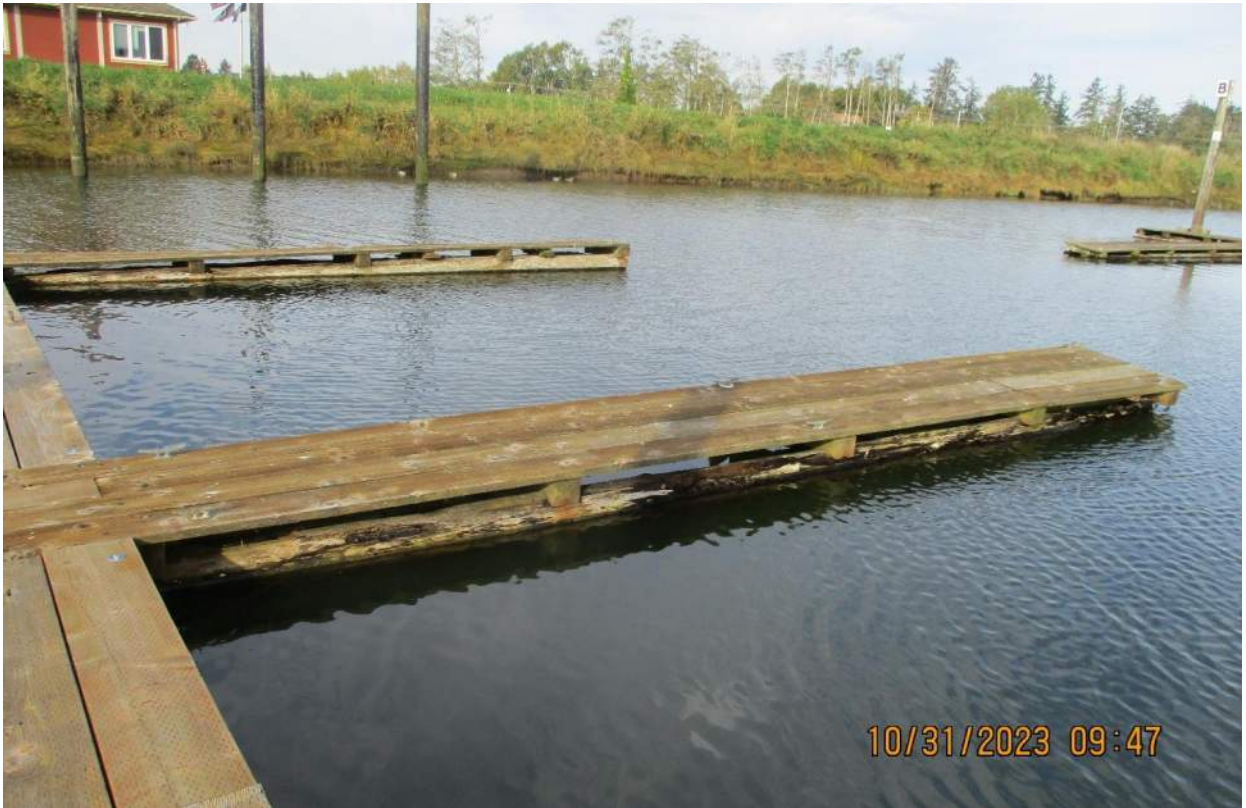
Photo 7:
Uneven finger piers due to lack of buoyancy in float logs.

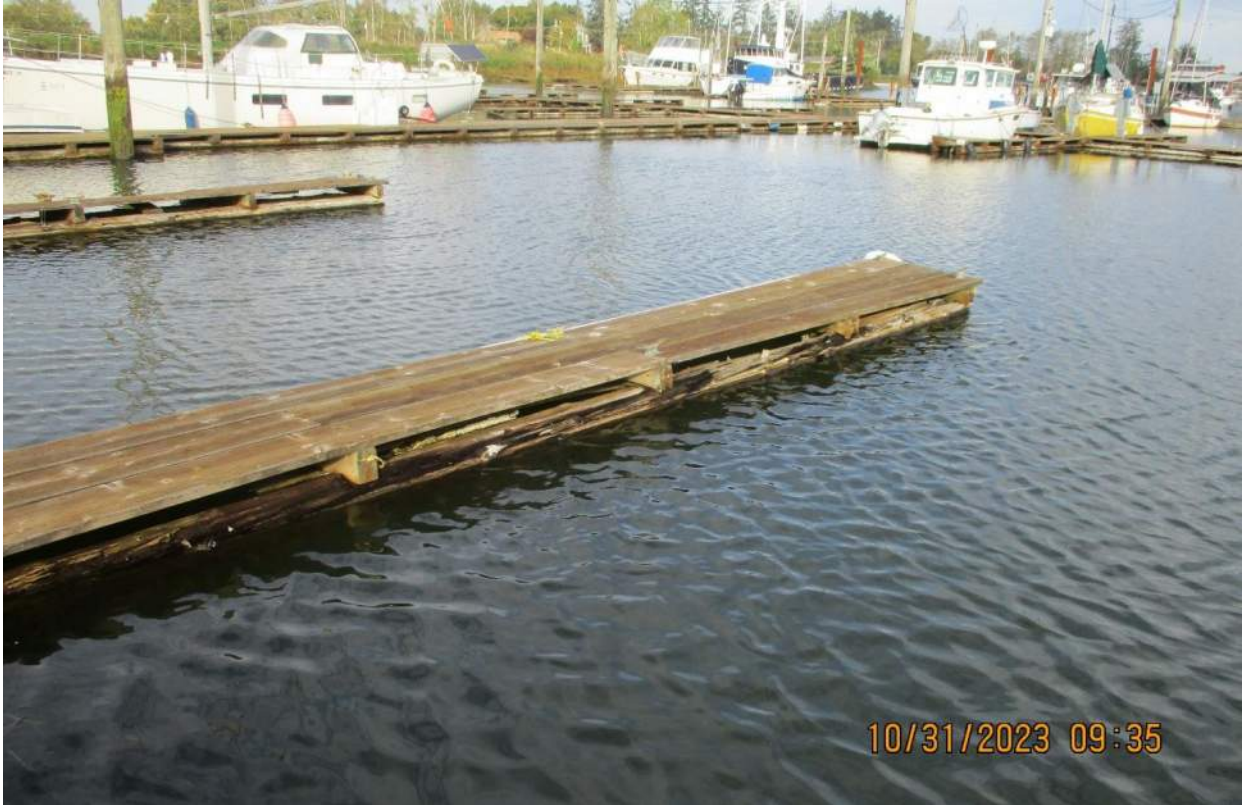
Photo 9:
Severely decayed float log, with significant tilt in the finger pier.

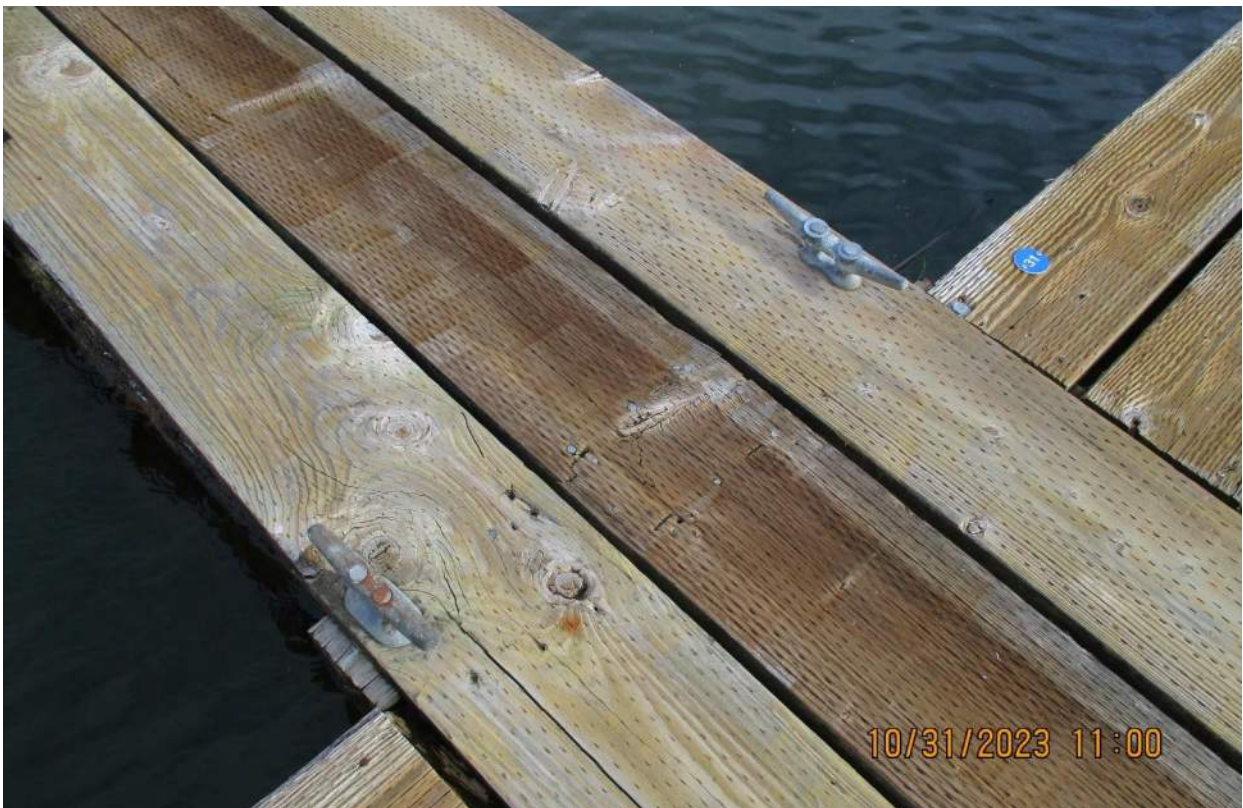
Typical deck condition. Note the finger pier decking intersecting and continuous over the main walkway.

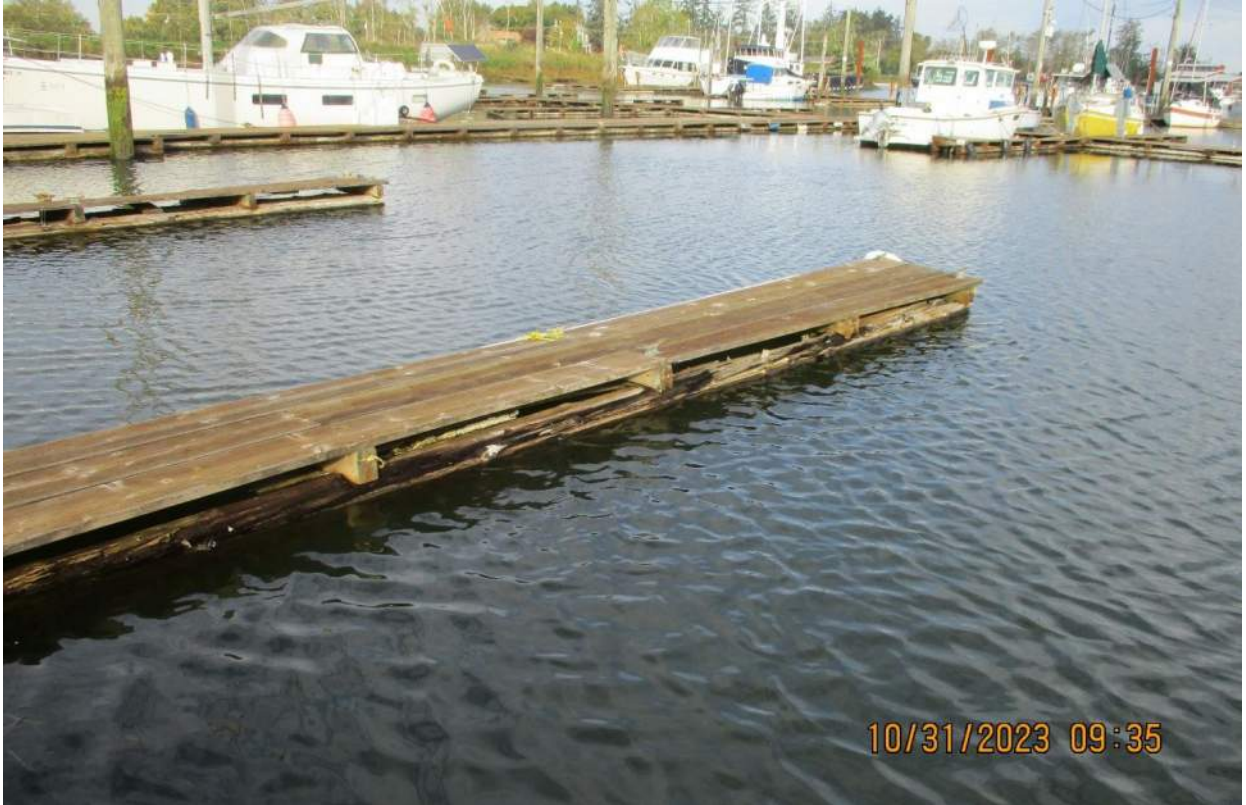
Photo 17:
Typical condition of existing trestles. Note the decay in the timber piling.

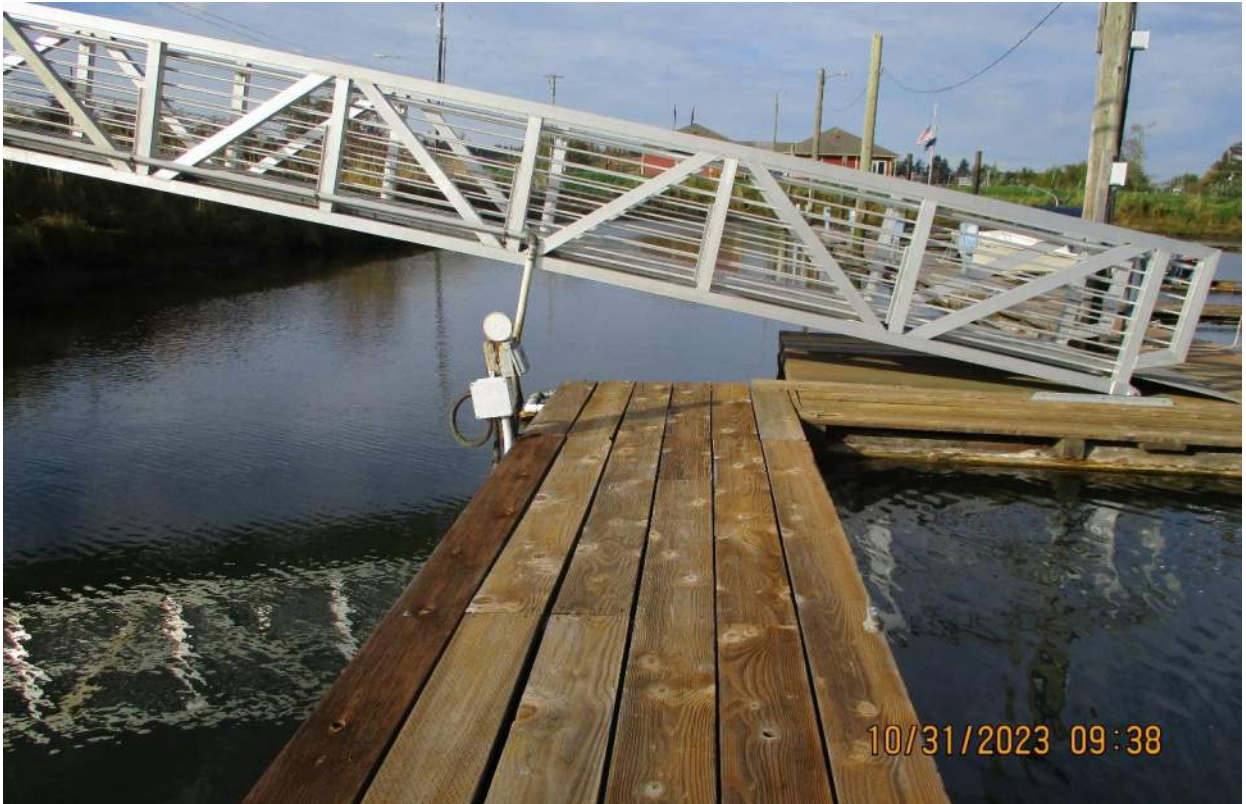
Photo 18:
Typical condition of the gangway

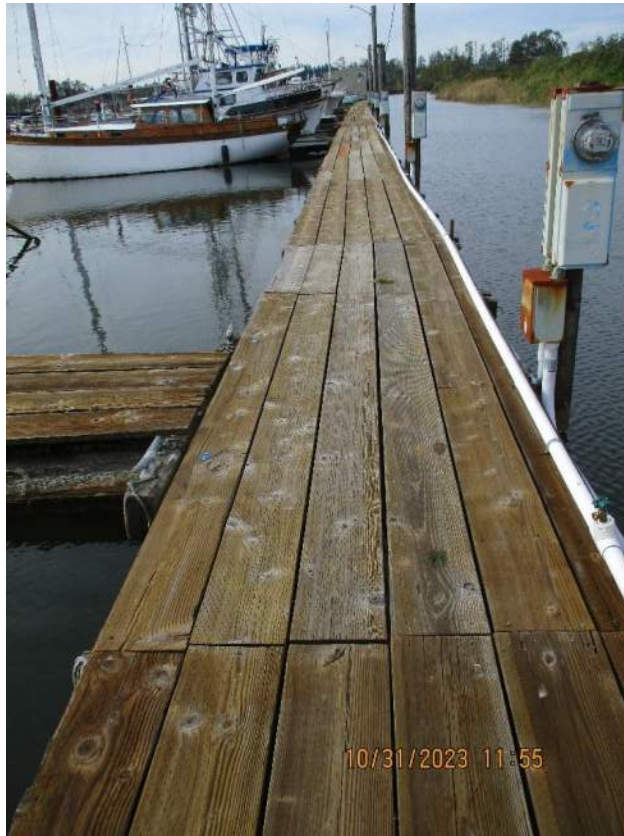
Photo 23:
Recently replaced water piping along Dock N. Should be a model for future piping repairs.

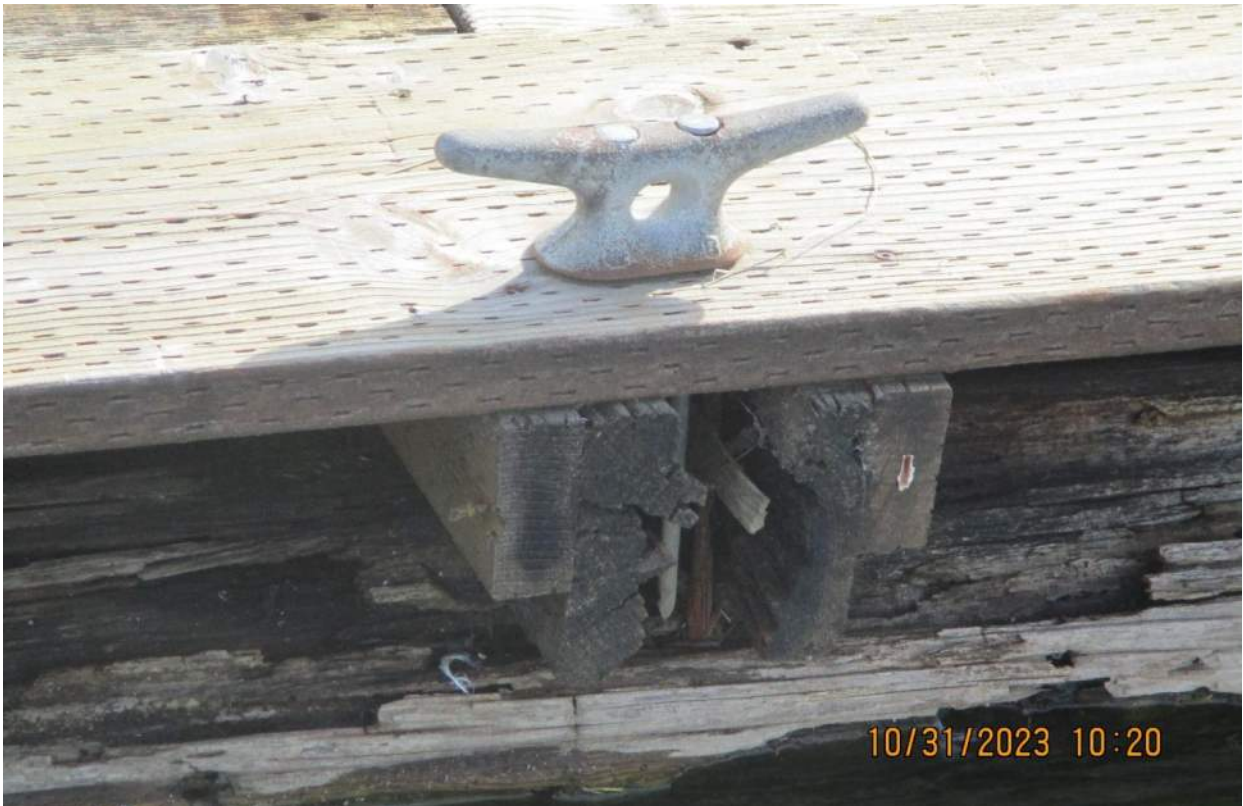
Photo 24:
Typical condition of cleat. Cleat is only restrained by the deck, stringer below is decayed.

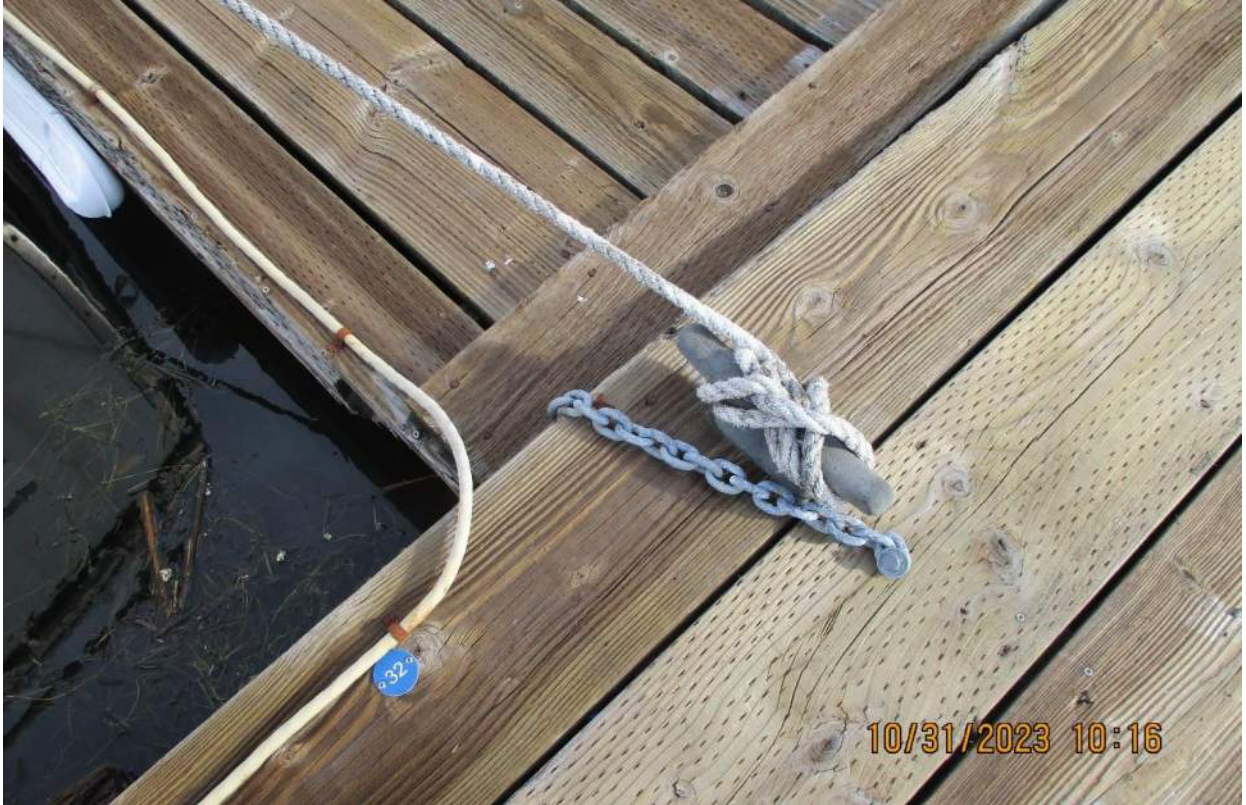
Photo 25:
Chain connection, with lag bolt into the deck. Unclear if lag bolt is into stringer below.

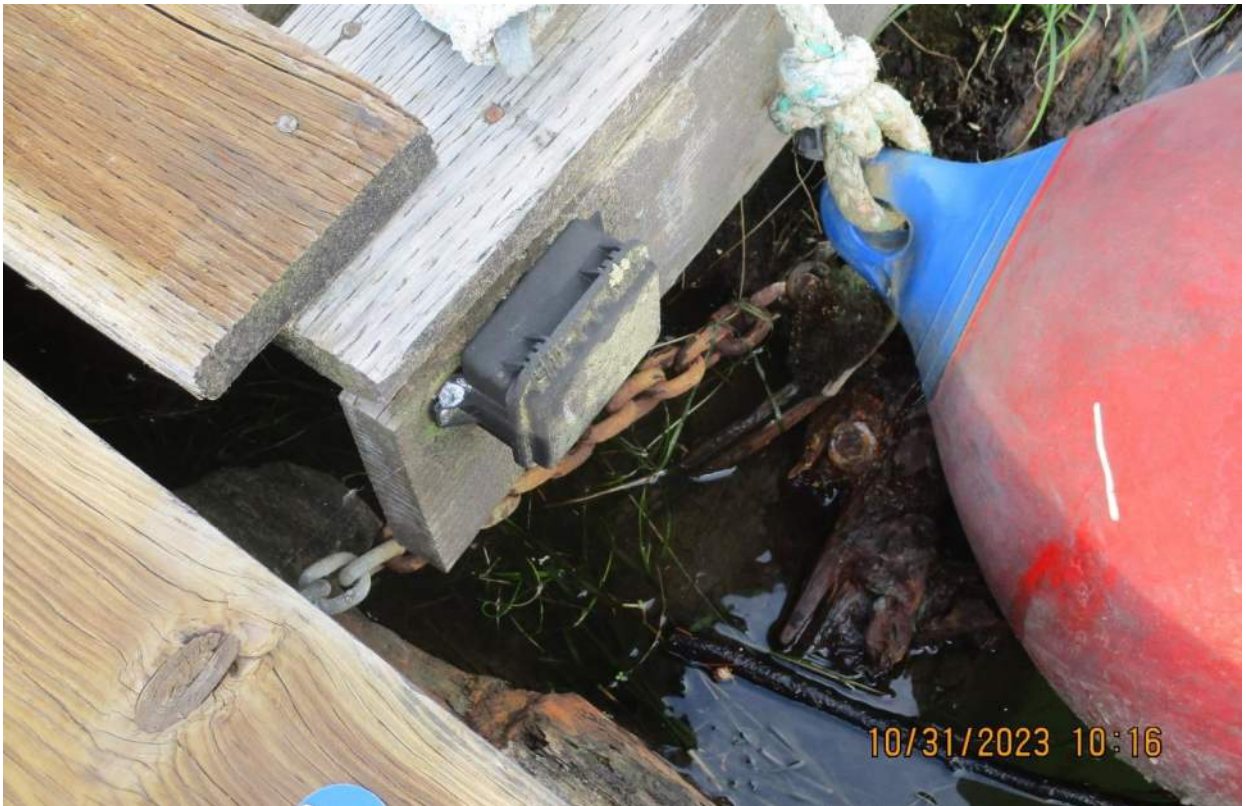
Photo 26:
Decayed chain connect. Note corrosion in chain and heavily corroded hardware in float log.

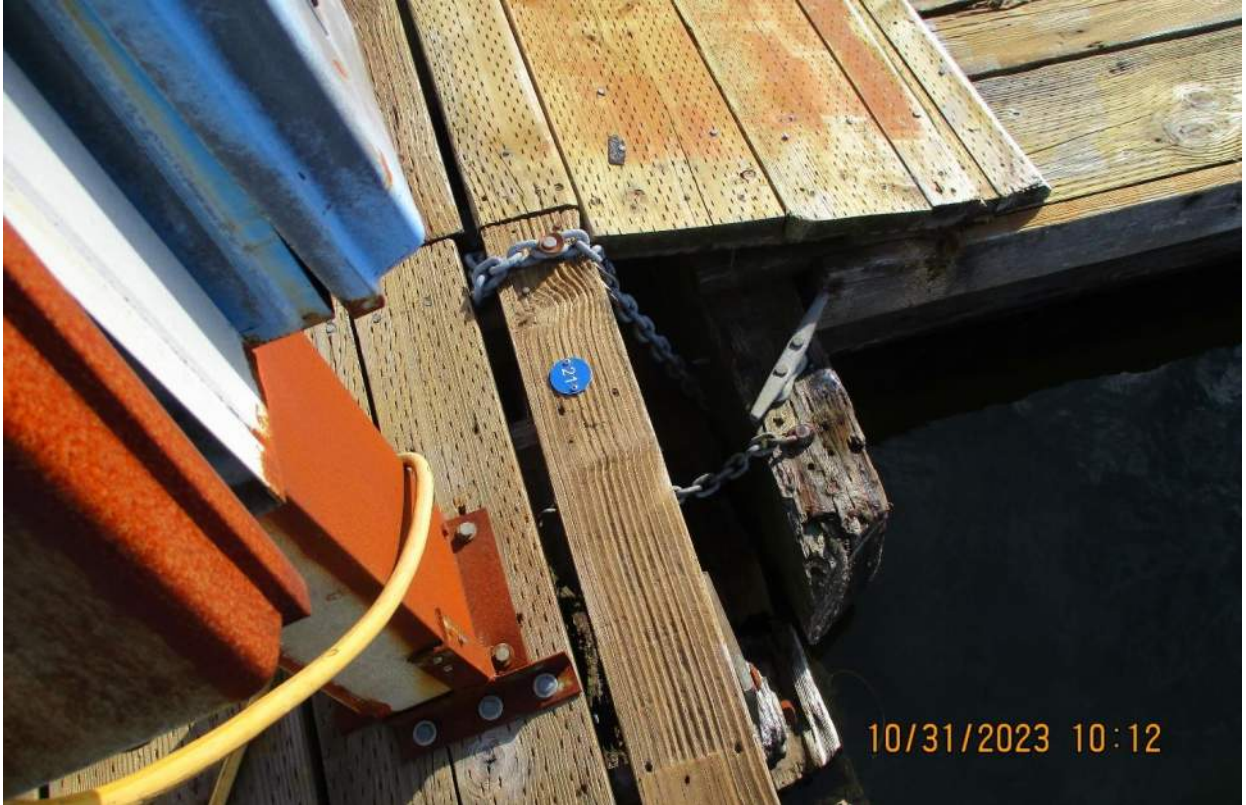
Photo 27:
Chain connection, lagged into deck only.

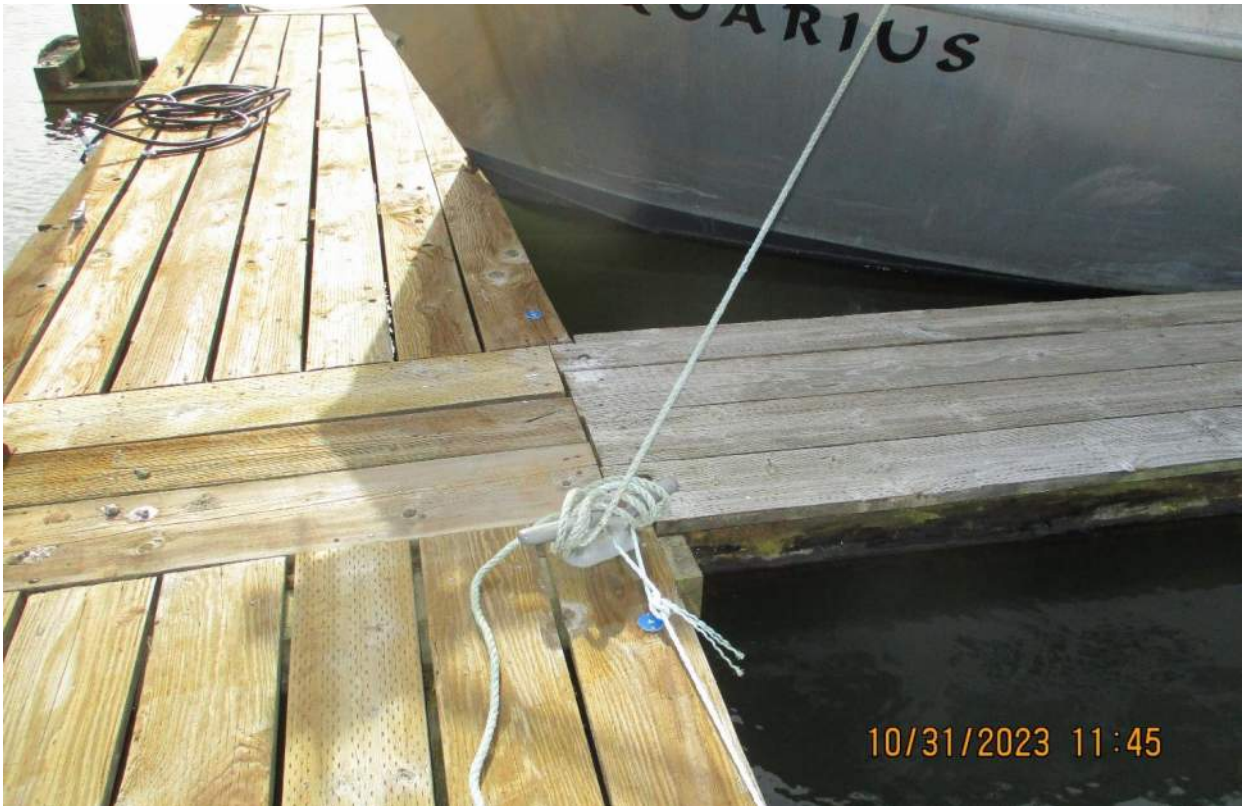
Photo 28:
Ledge type connection where finger pier meets main walkway.

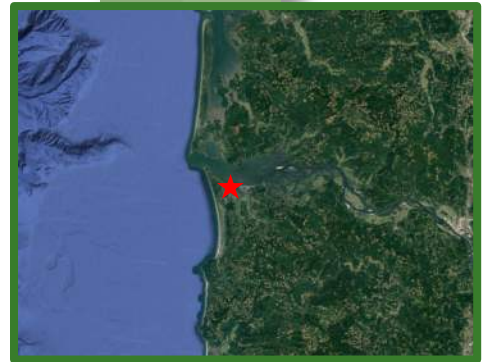
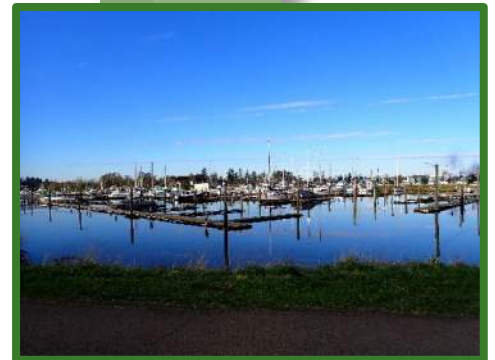
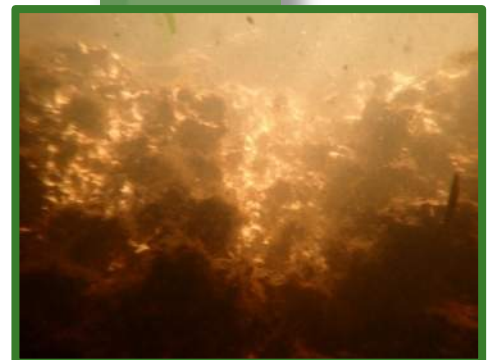
COLLINS
ENGINEERS INC.
7576 W. Victory Rd.
Boise, Idaho 83709
208.254.1266 • www.collinsengr.com

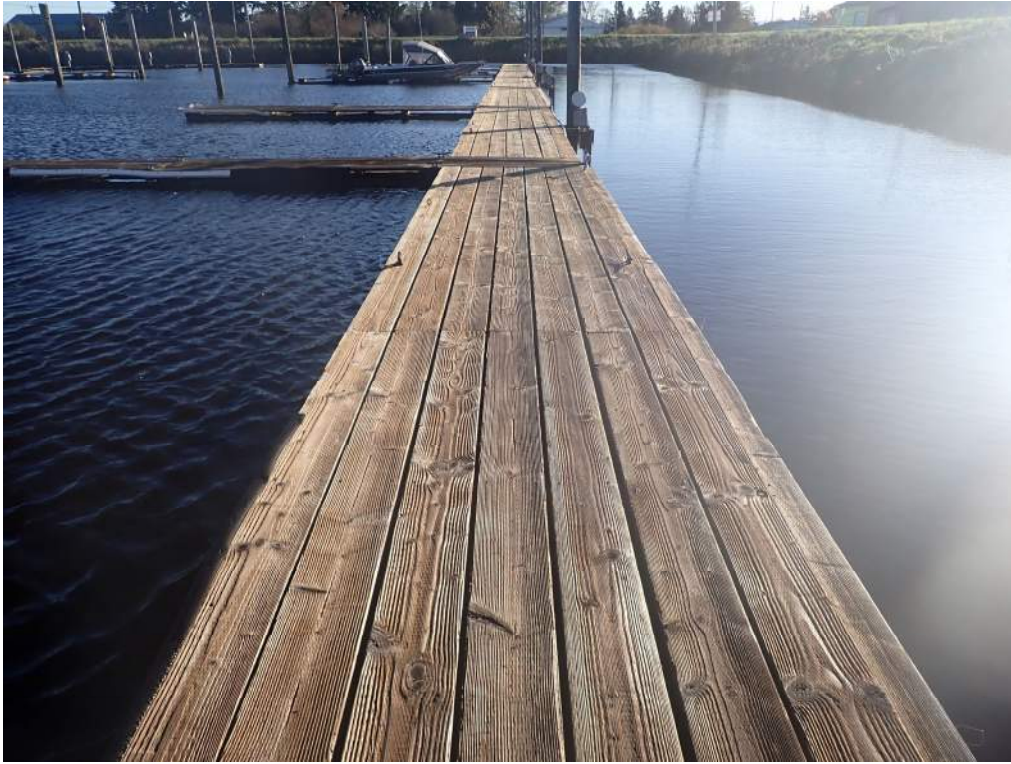
Photograph 7– Typical Main Floating Dock Condition

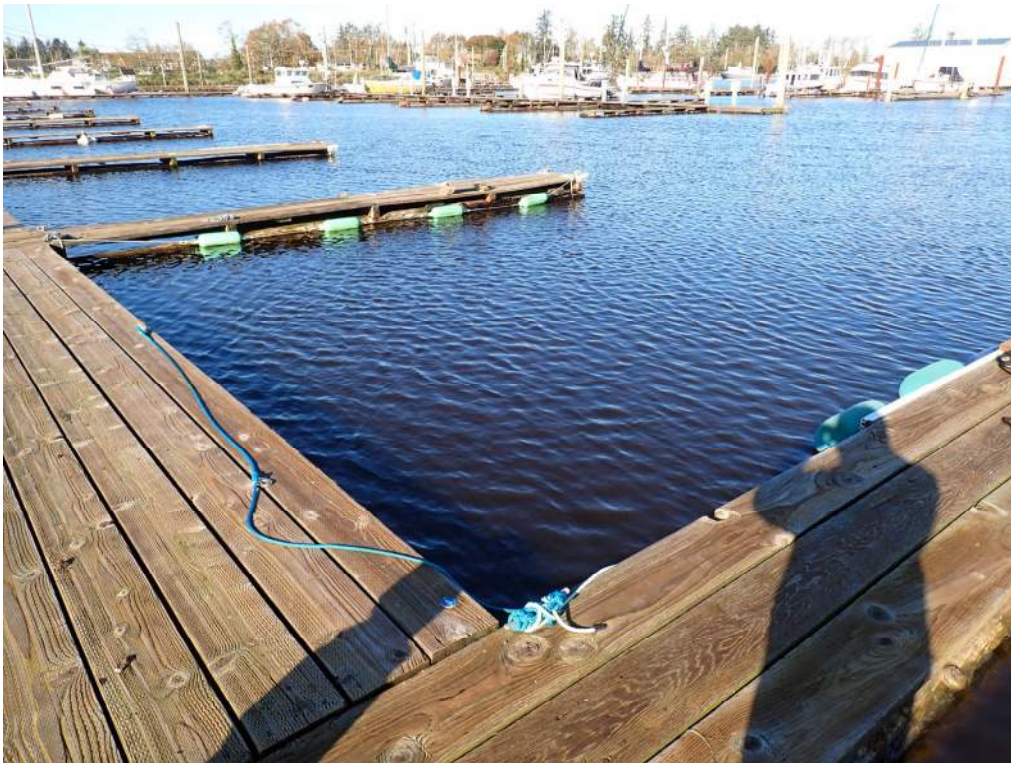
Photograph 8– Typical Finger Pier Condition

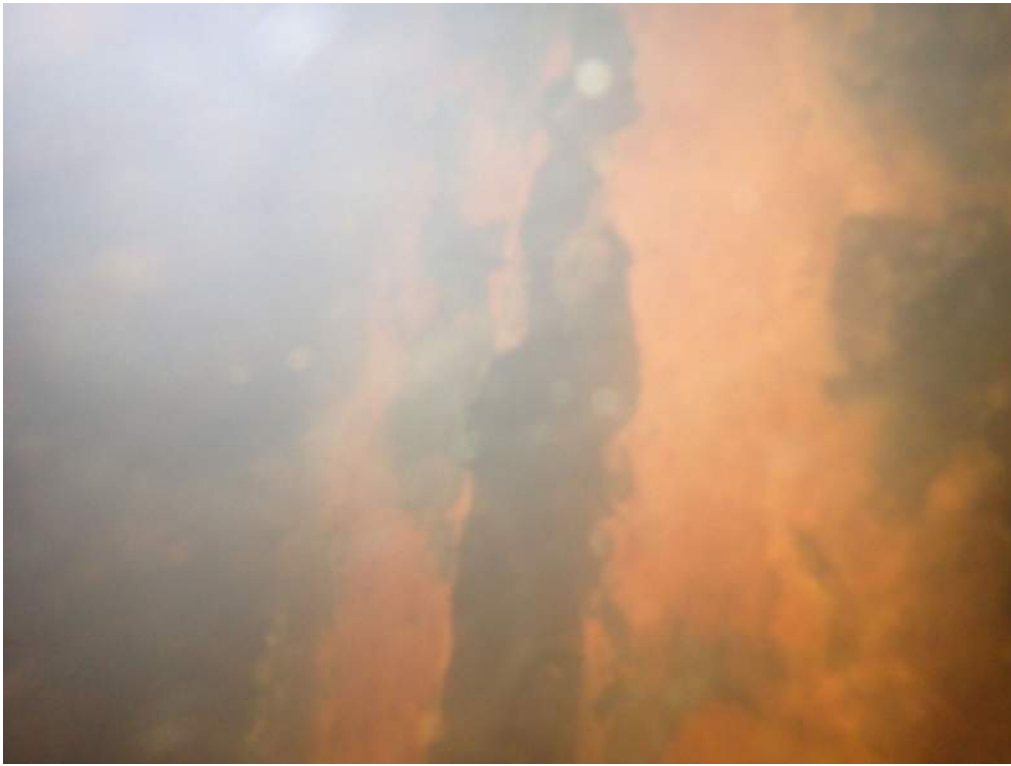
Photograph 23– Corrosion Hole in Steel Pile at Dock A , Between Slips 27 and 28

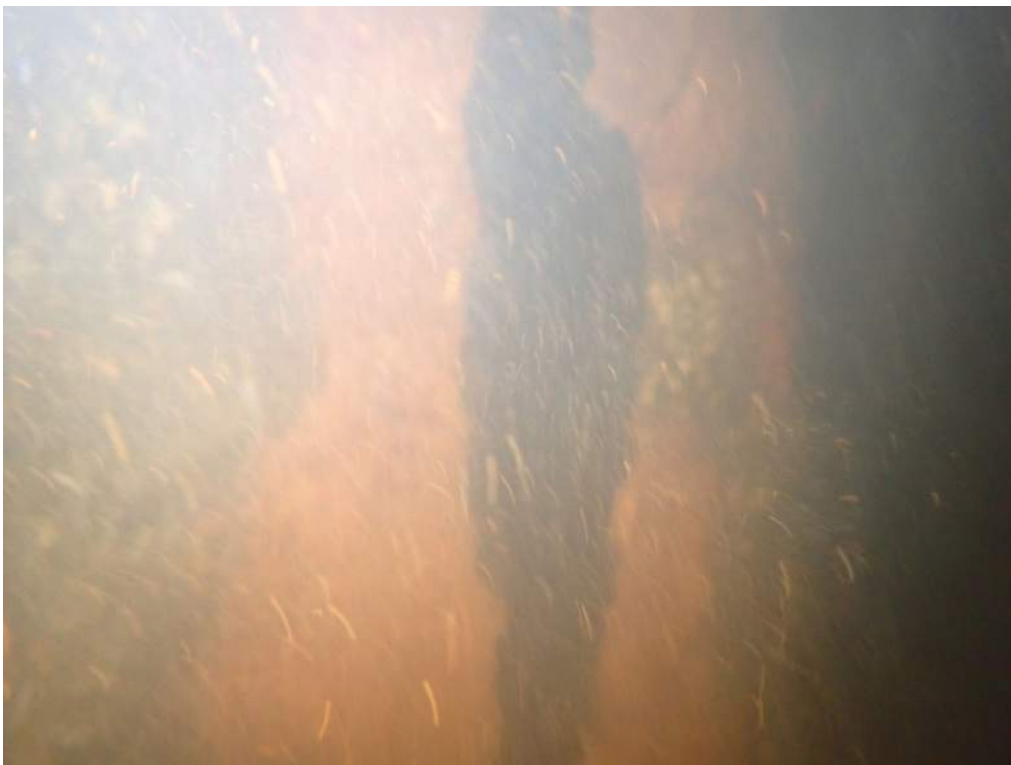
Photograph 24– Corrosion Hole in Steel Pile at Dock A, Between Slips 25 and 26

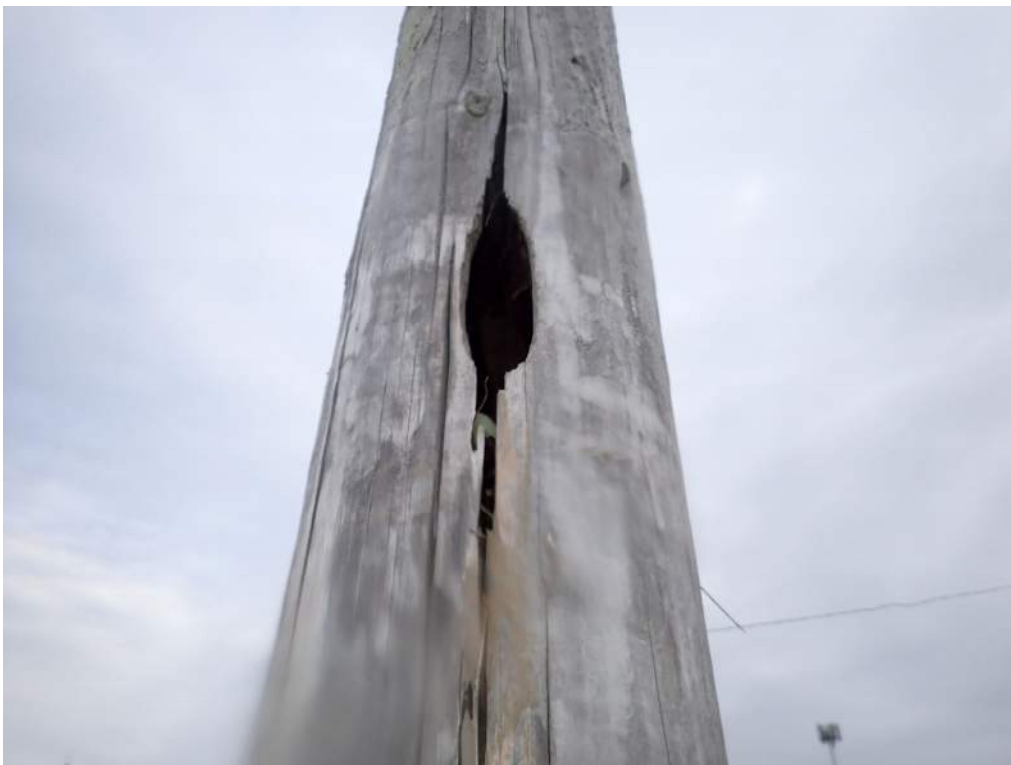
Photograph 26– Typical Severe Loss of Section in Timber Guide Piles

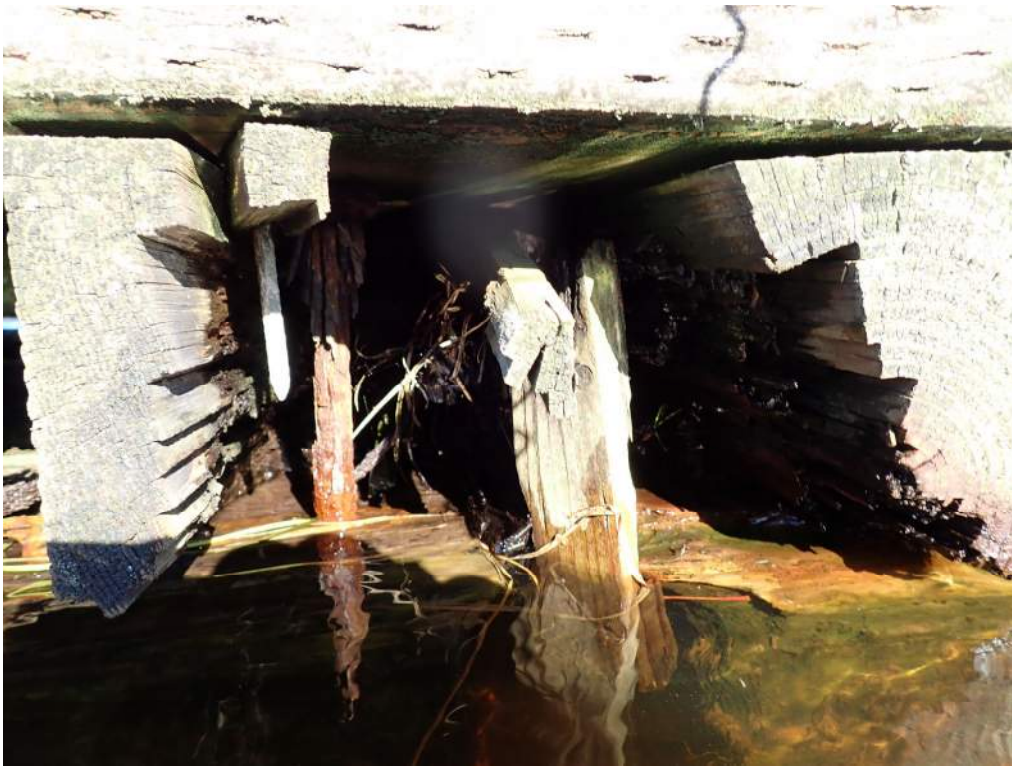
Photograph 29– Loose Connection Between Timber Float and Transverse Timber Support

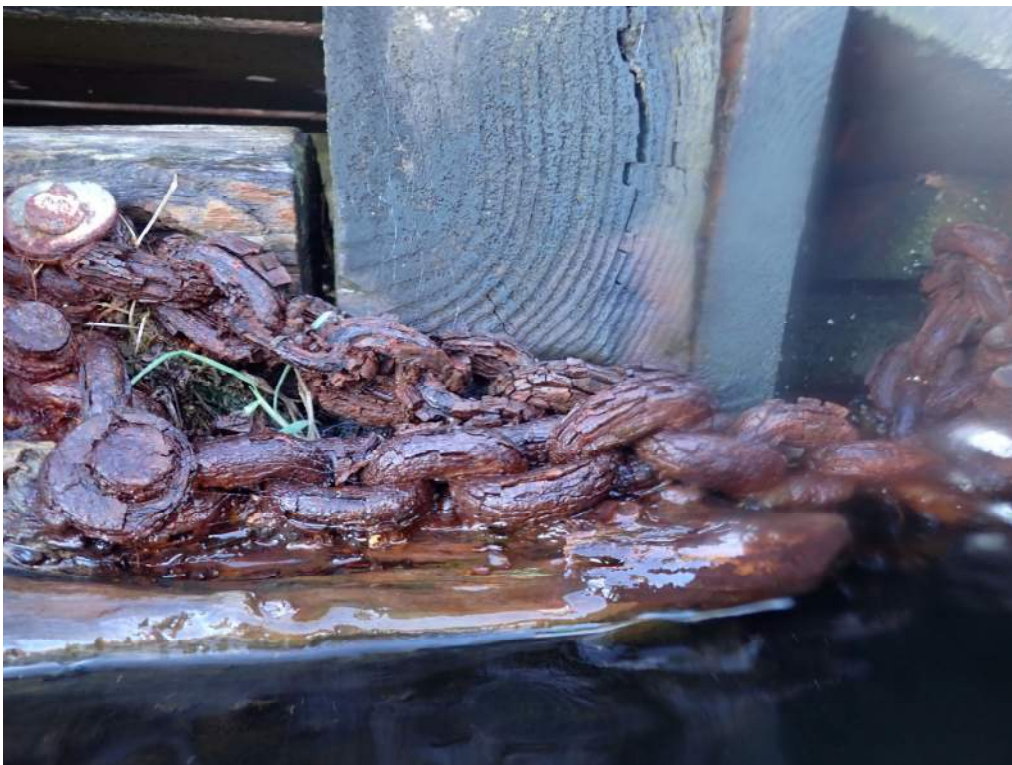
Photograph 30– Flaking Rust at Chain Connection at Dock C, Slip 36

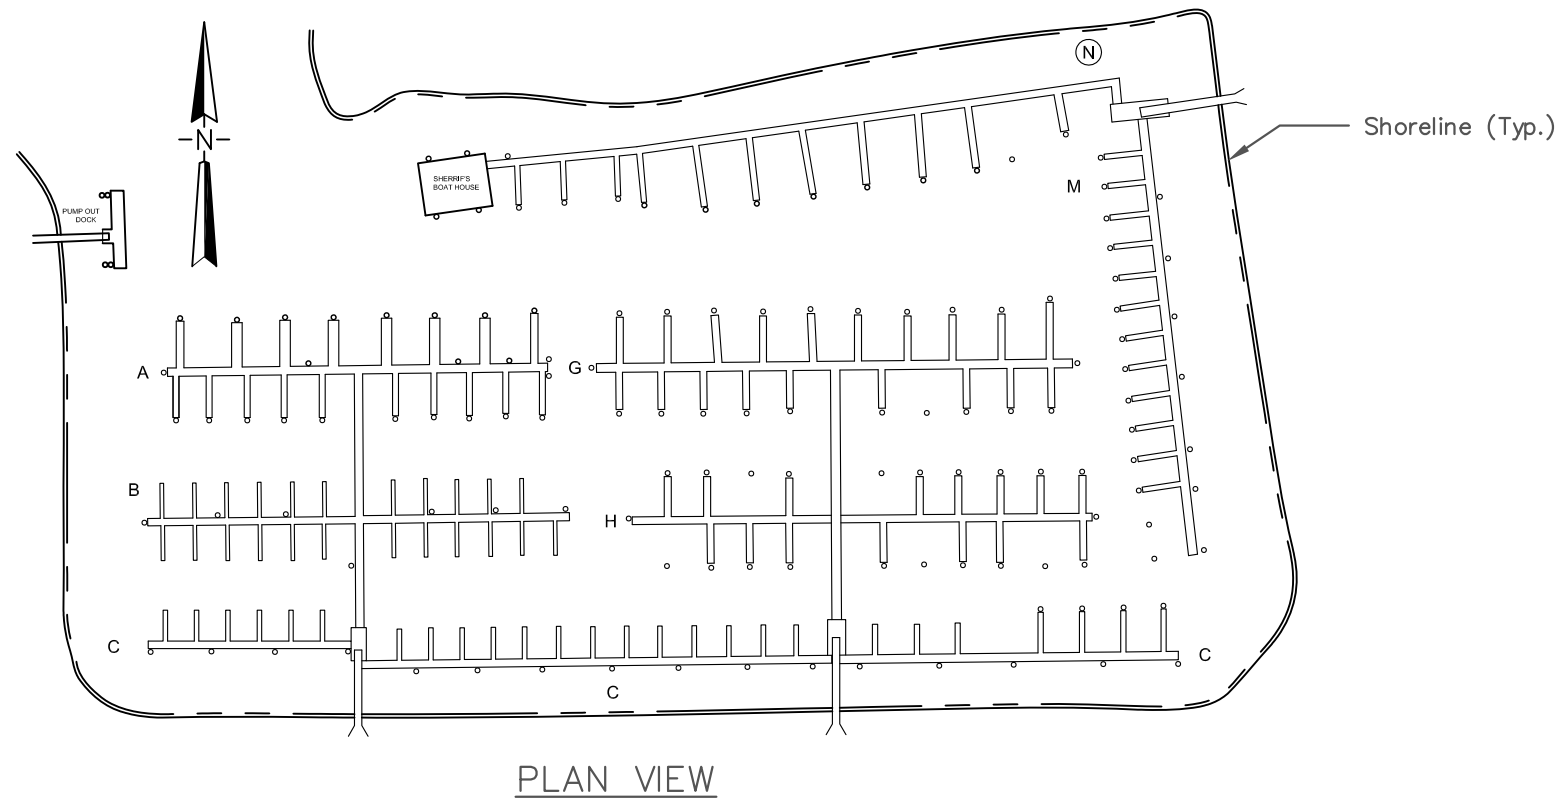
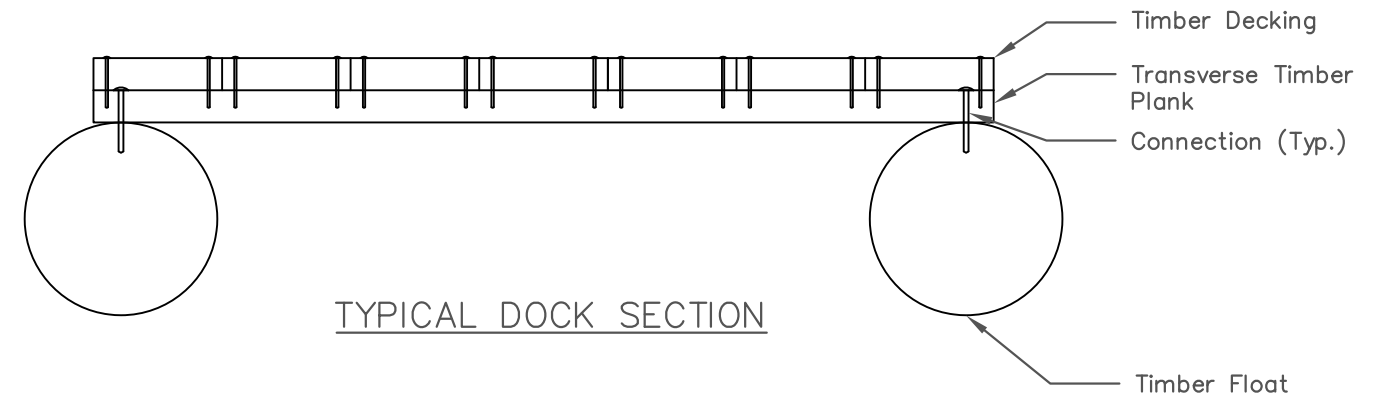
WARRENTON MARINA UNDERWATER INSPECTION
