MARINA ADVISORY COMMITTEE

February 26, 2024 at 2pm

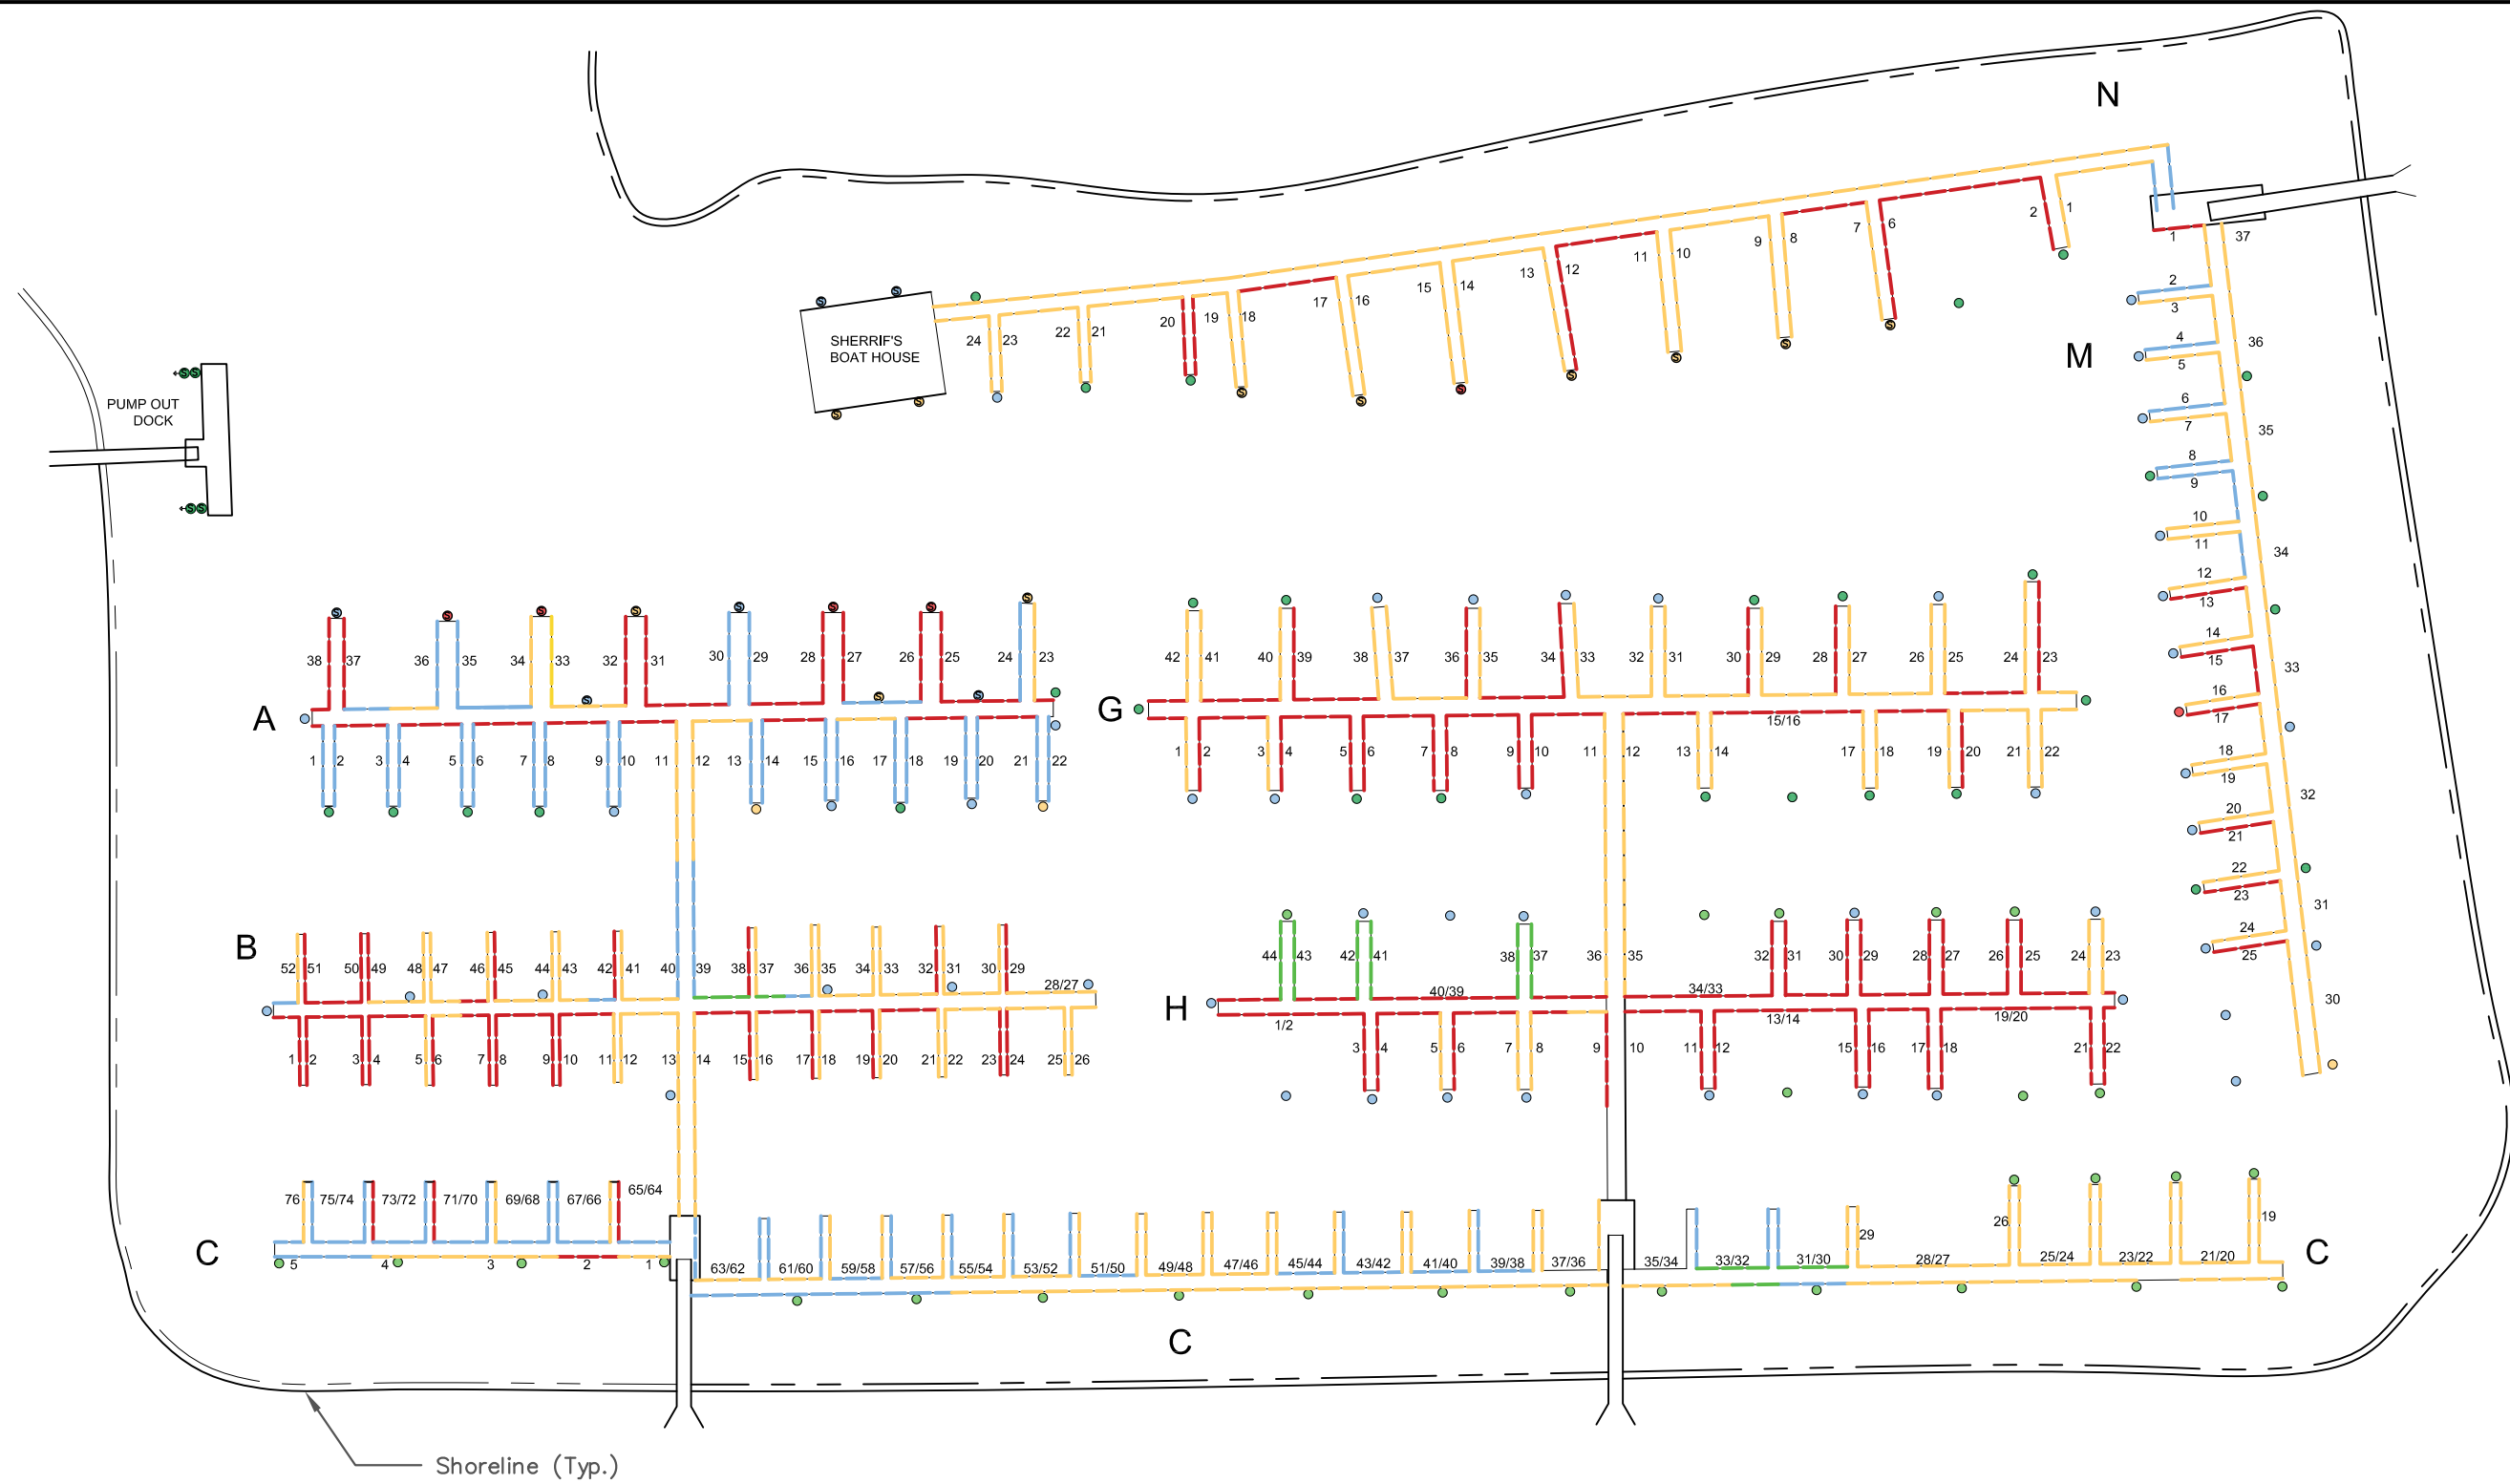
Date: 11/14/2023
Scale: NTS
Figure No.: T-01

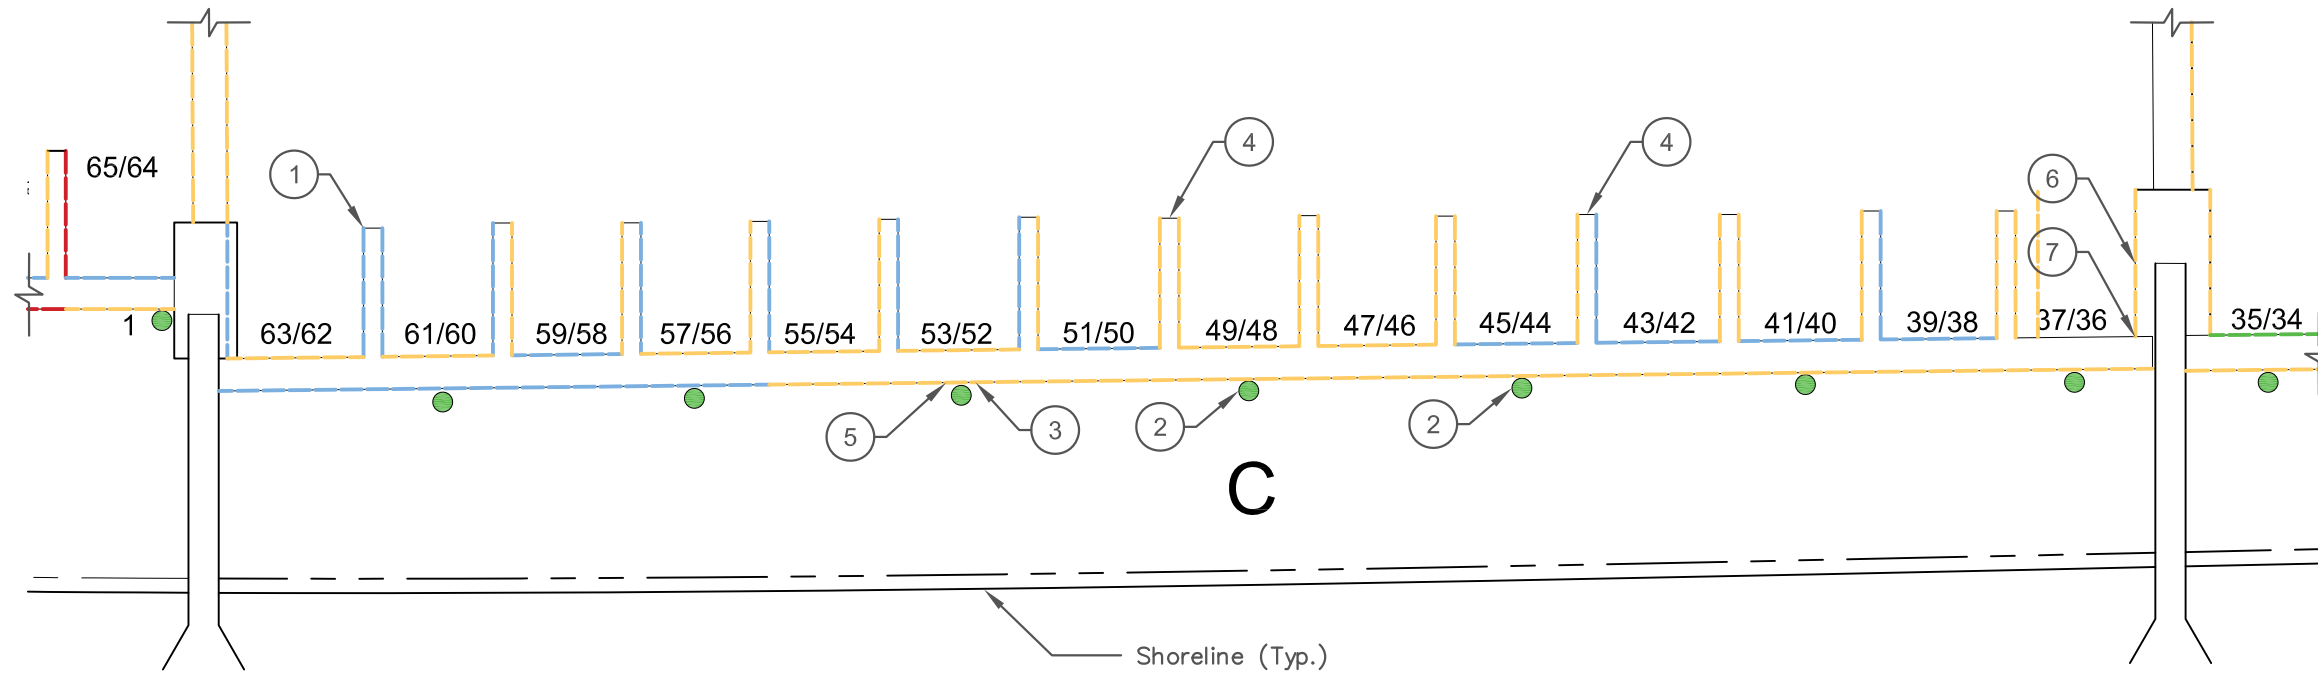
Drawn By: CCT	 7576 W. Victory Rd. Boise, ID 83709 (208) 297-5324 www.collinsengr.com	Date: 11/14/2023
Checked By: JTF		Scale: NTS
Project: 14994.00		Figure No.: I-04

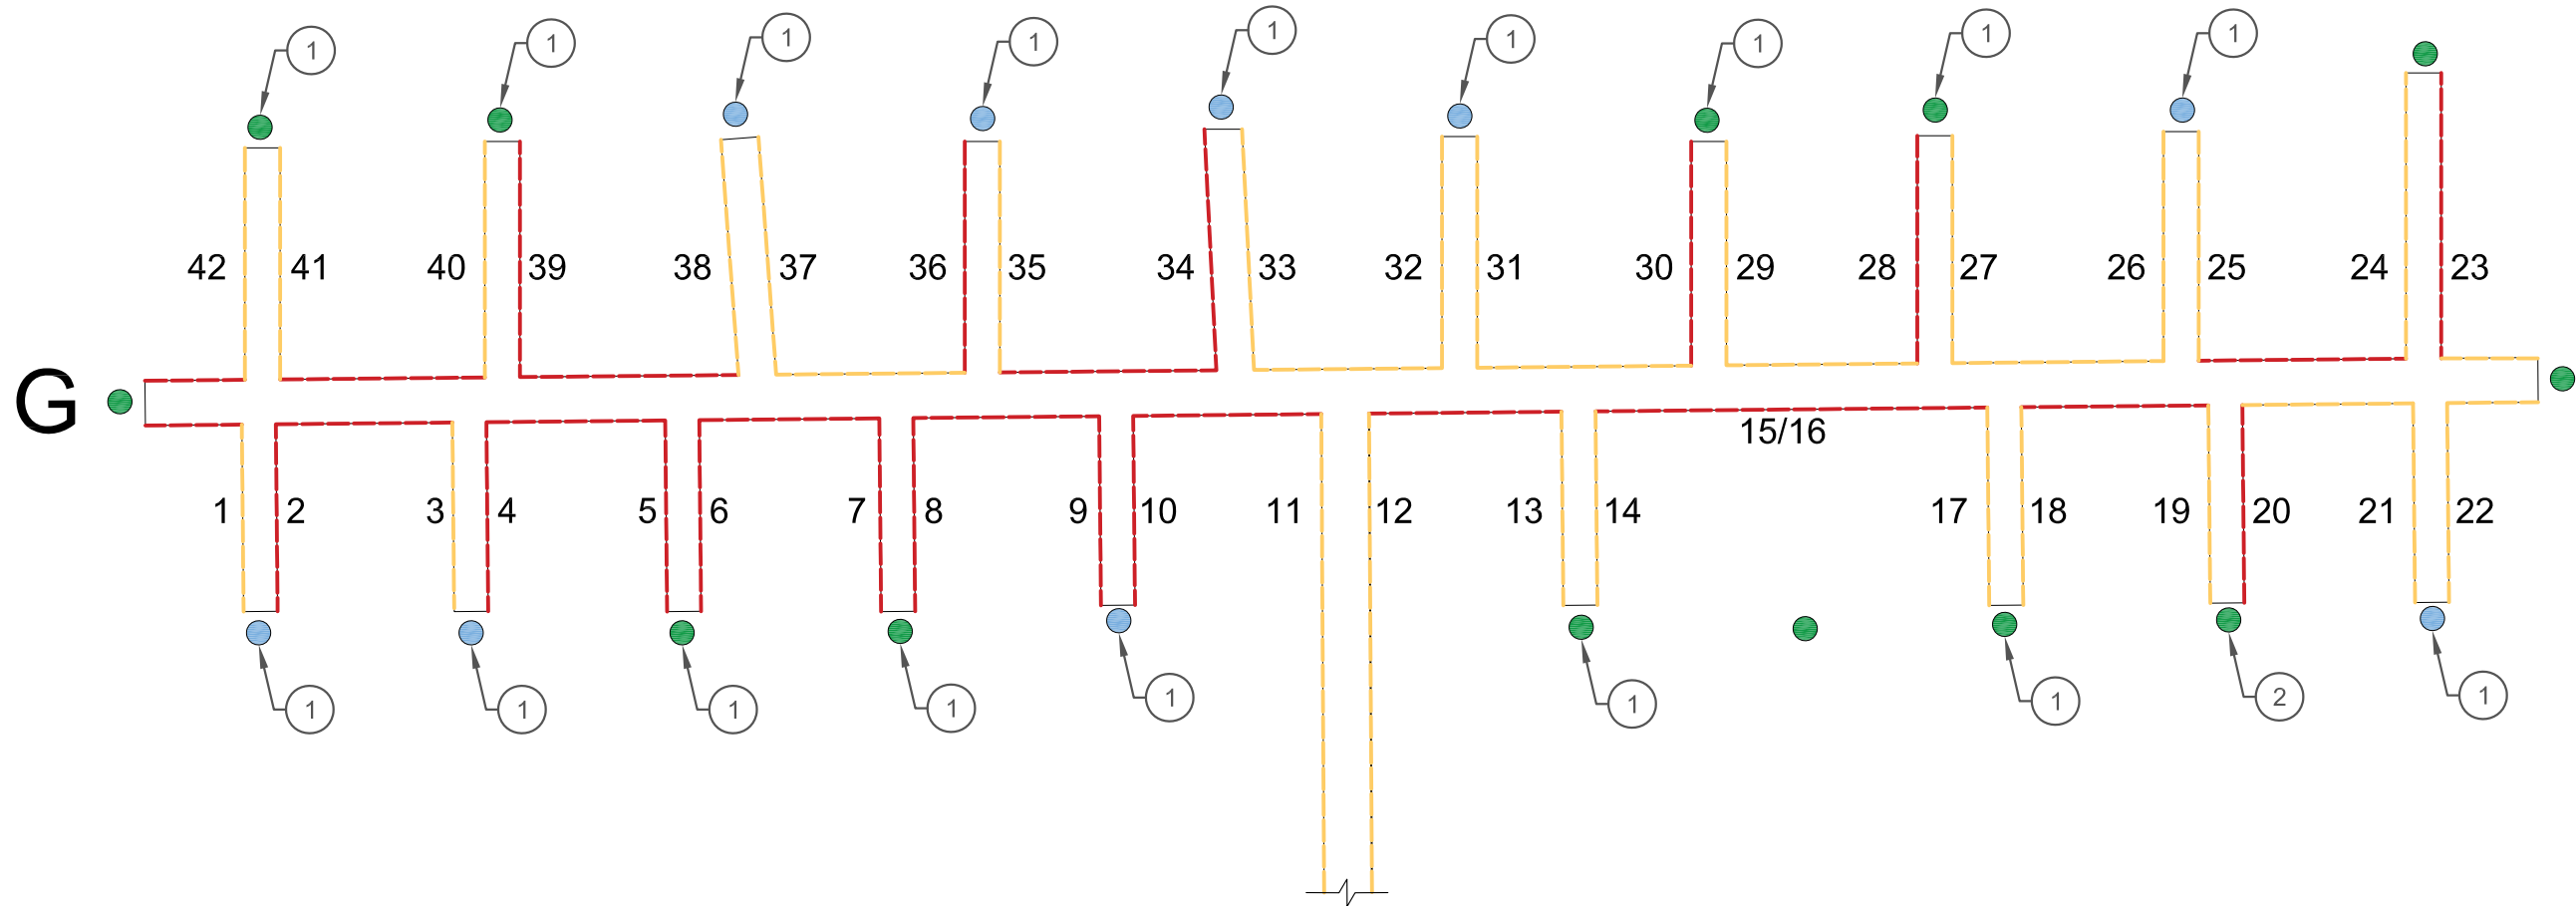
WARRENTON MARINA		
UNDERWATER INSPECTION PLAN		
DOCK C (EAST SECTION)		
Drawn By: CCT	COLLINS ENGINEERS <small>7576 W. Victory Rd. Boise, ID 83709 (208) 297-5324 www.collinsengr.com</small>	Date: 11/14/2023
Checked By: JTF		Scale: NTS
Project: 14994.00		Figure No.: I-06

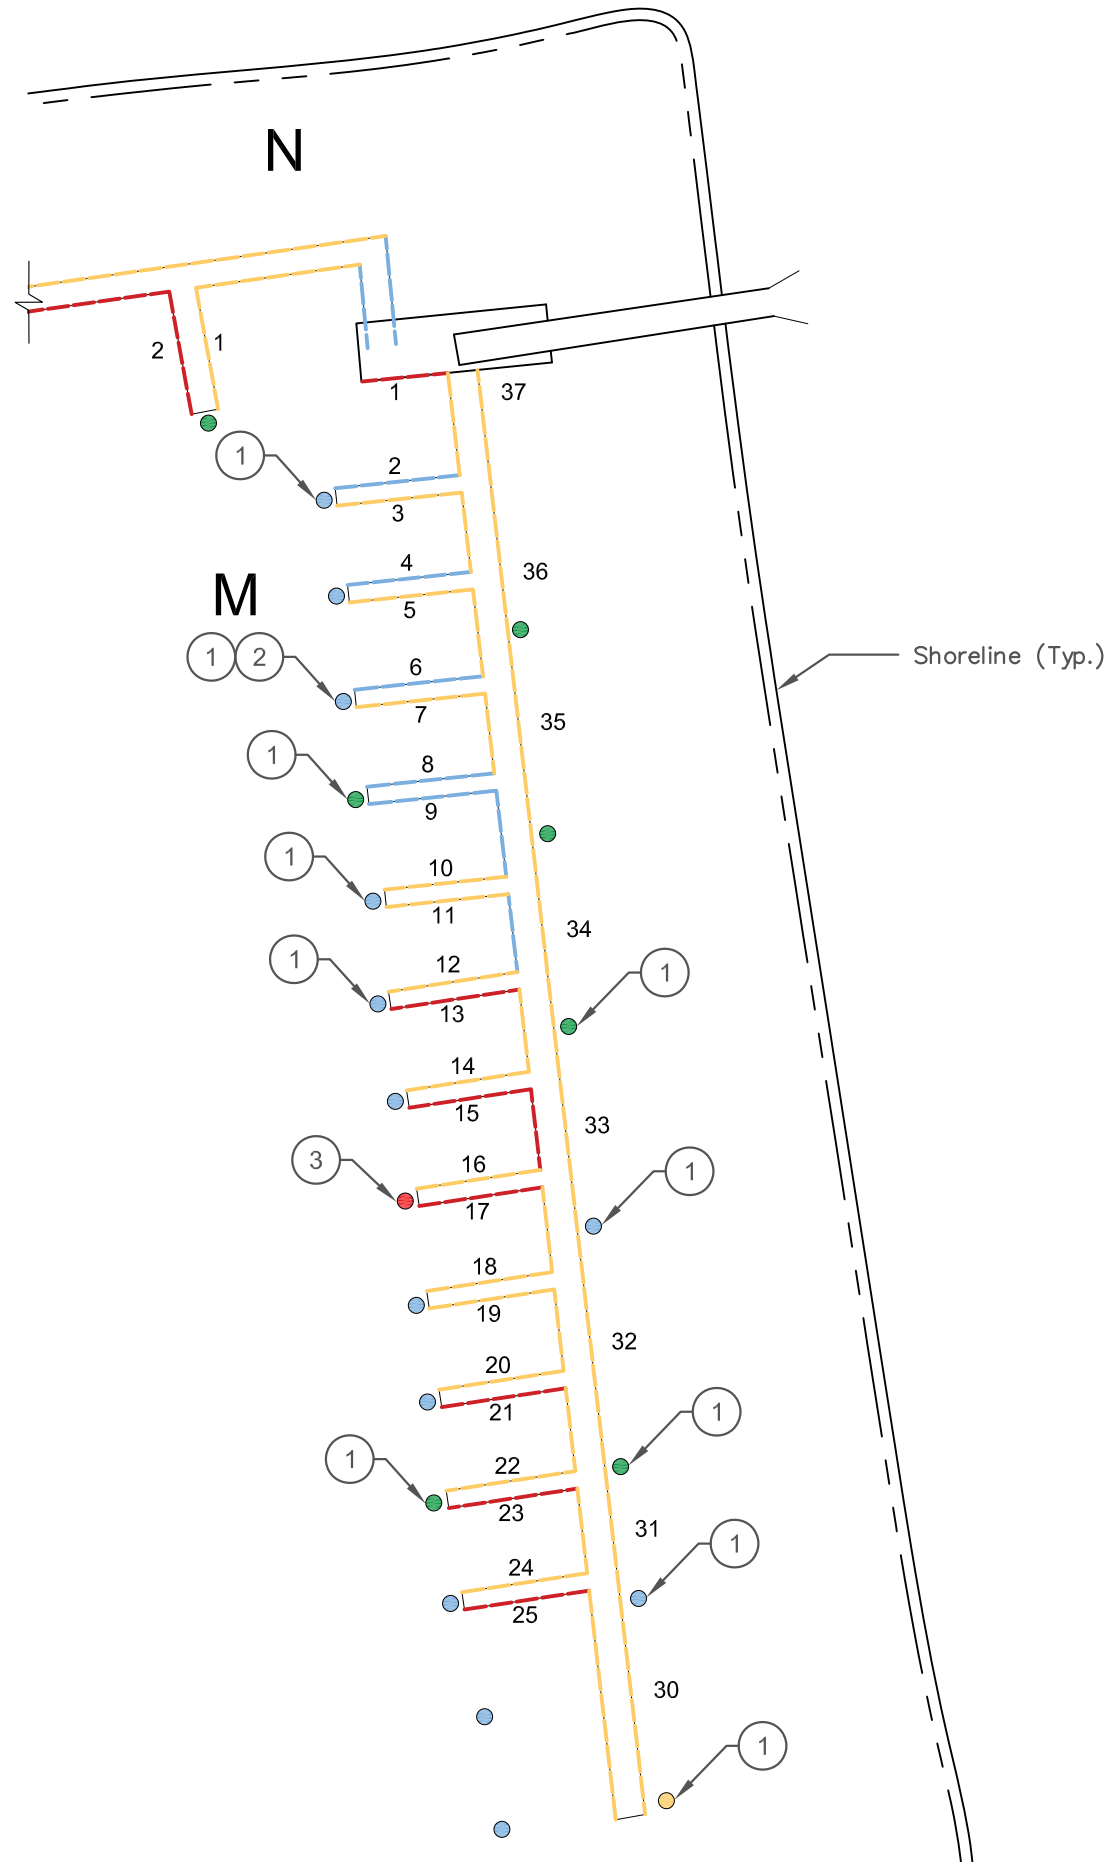
WARRENTON MARINA		
UNDERWATER INSPECTION PLAN		
DOCK H		
Drawn By: CCT	COLLINS ENGINEERS <small>7576 W. Victory Rd. Boise, ID 83709 (208) 297-5324 www.collinsengr.com</small>	Date: 11/14/2023
Checked By: JTF		Scale: NTS
Project: 14994.00		Figure No.: I-08

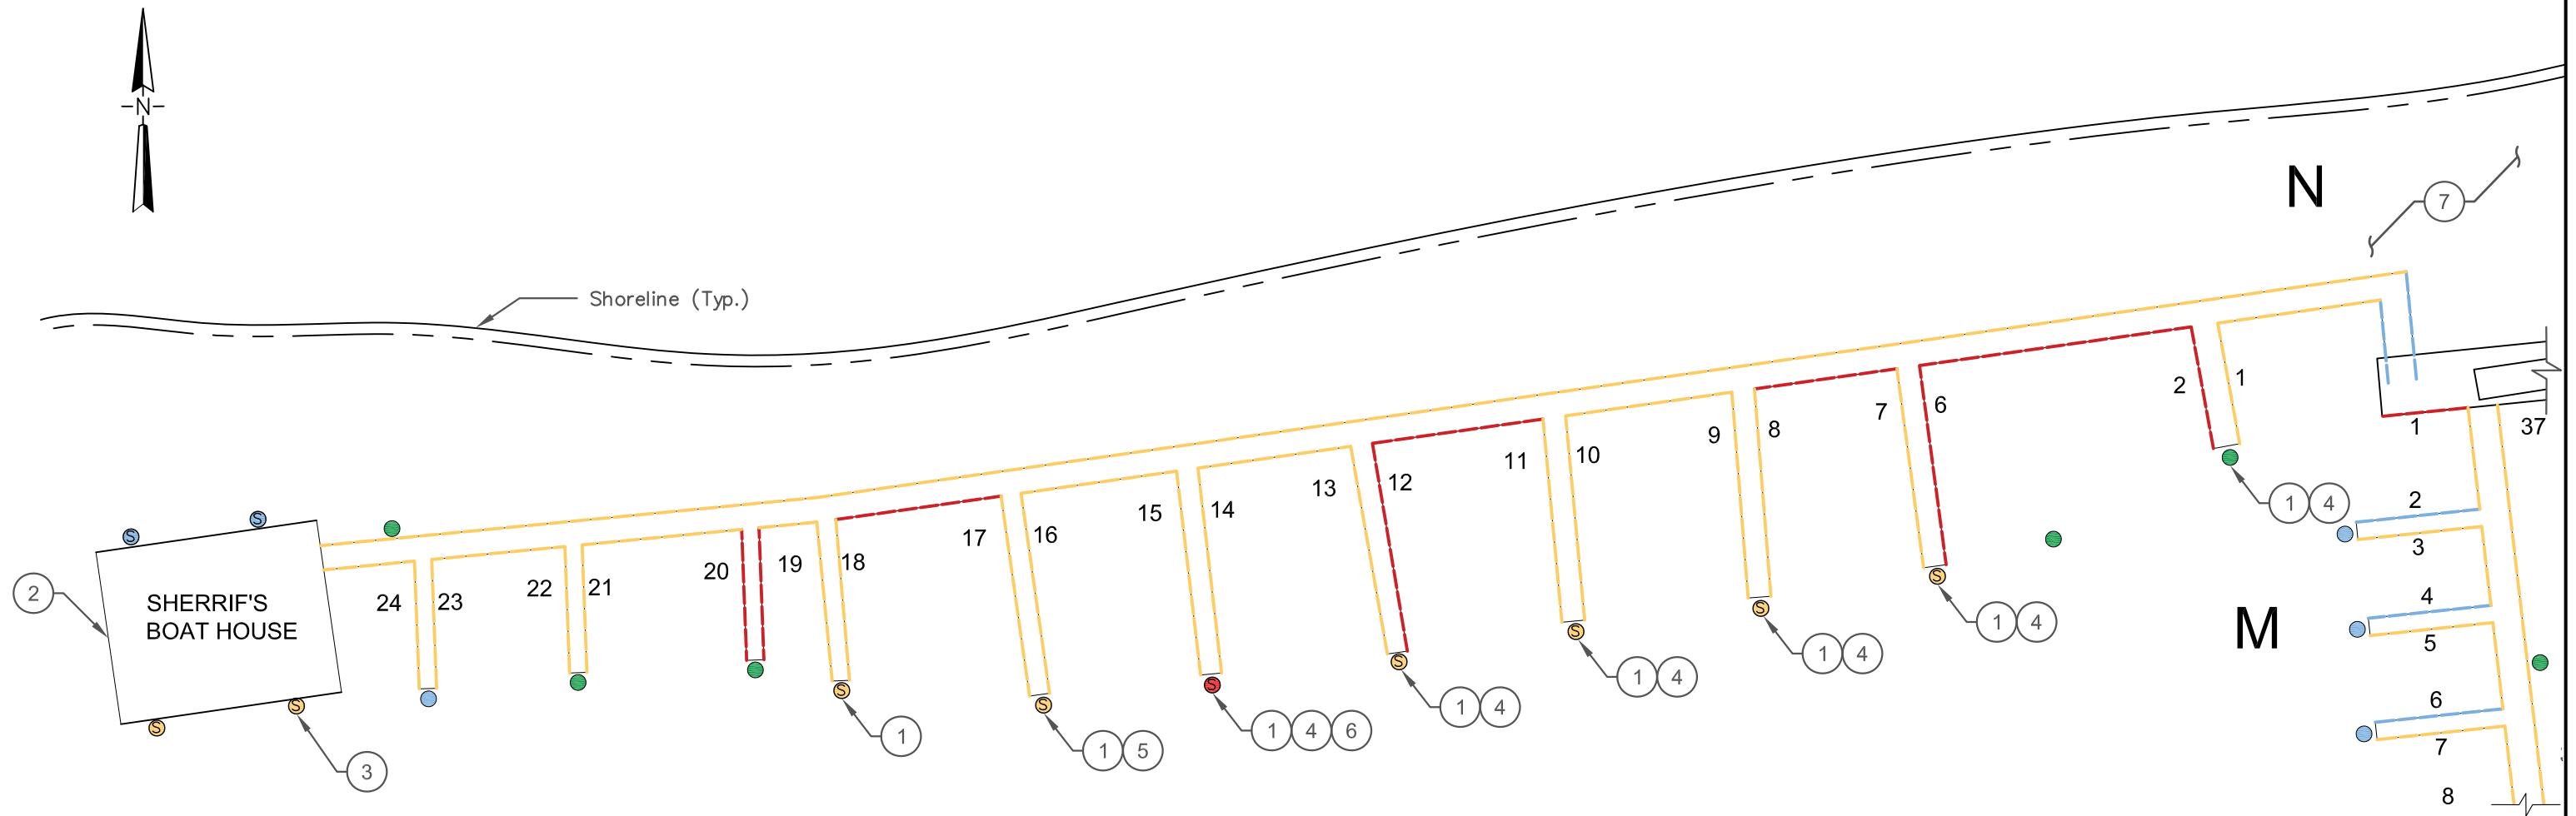
Drawn By: CCT	 <small>7576 W. Victory Rd. Boise, ID 83709 (208) 297-5324 www.collinsengr.com</small>	Date: 11/15/2023
Checked By: JTF		Scale: NTS
Project: 14994.00		Figure No.: I-09

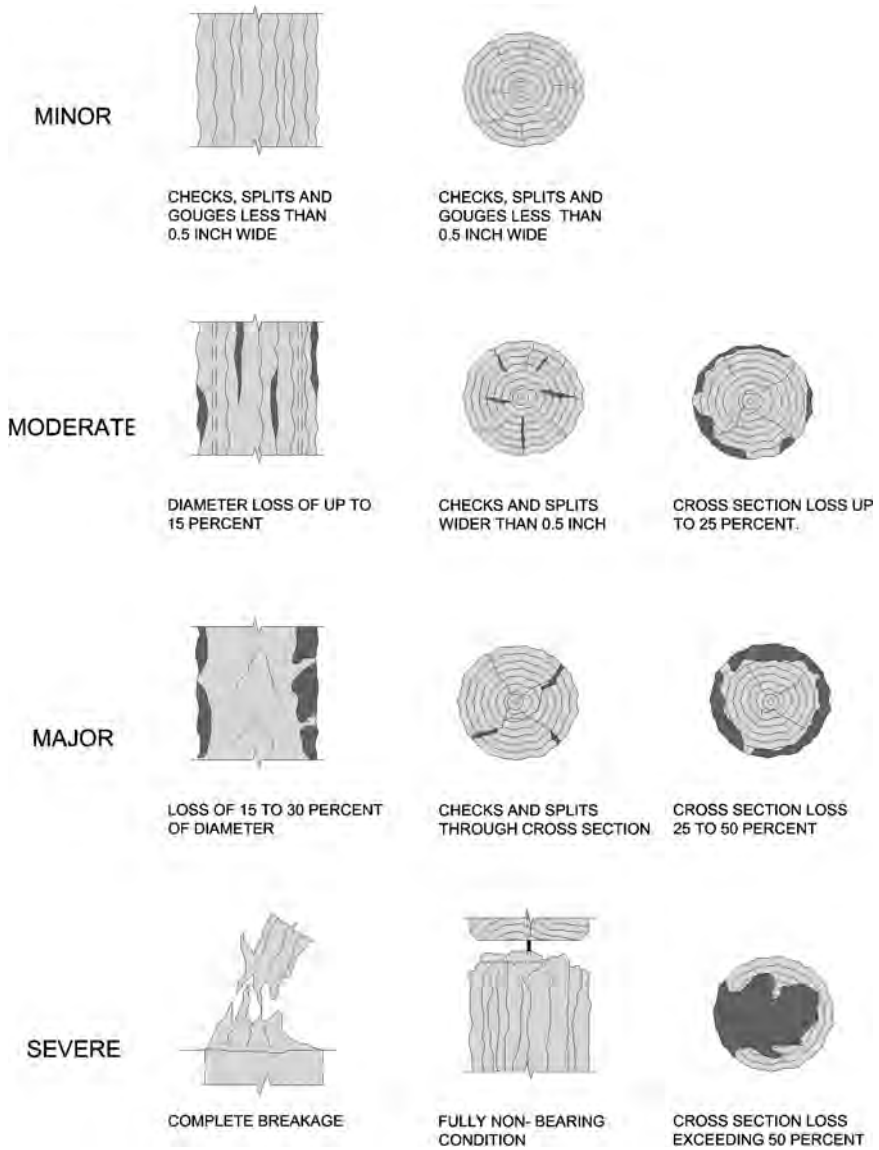
Fig. 2-2. Condition ratings for timber elements
 Source: Courtesy of CH2M HILL, Inc. and COWI, Inc., reproduced with permission.

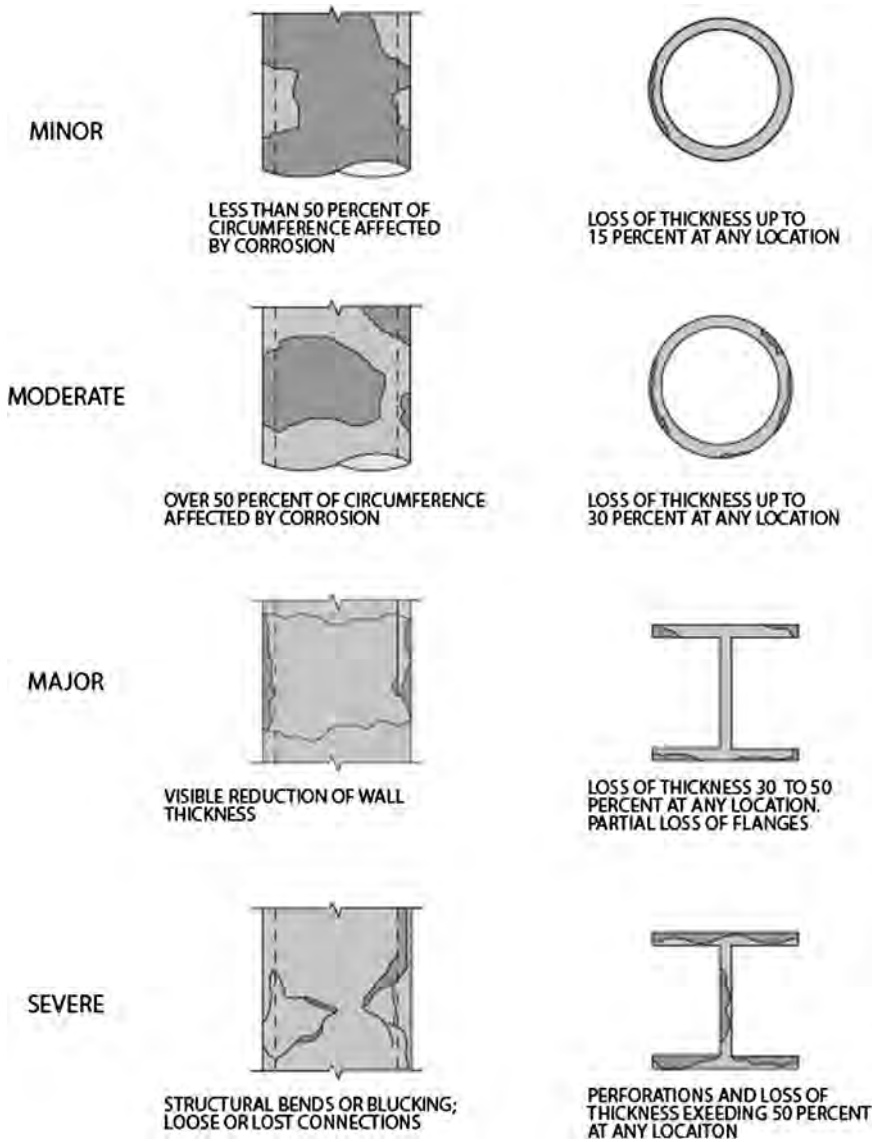
Fig. 2-3. Damage ratings for steel elements
 Source: Courtesy of CH2M HILL, Inc. and COWI, Inc., reproduced with permission.
