# Condition Survey and Load Rating Report – FINAL

**City of Warrenton  
Warrenton Marina Work Pier**

**July 2017**

**BergerABAM  
700 NE Multnomah St, Suite 500  
Portland, OR 97233**

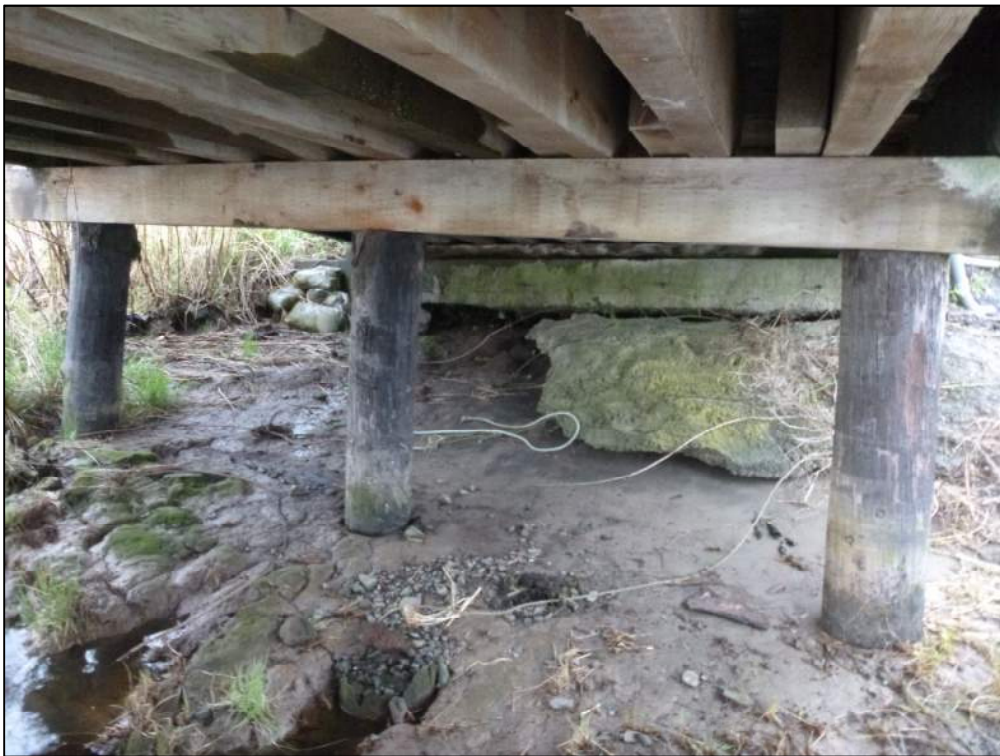
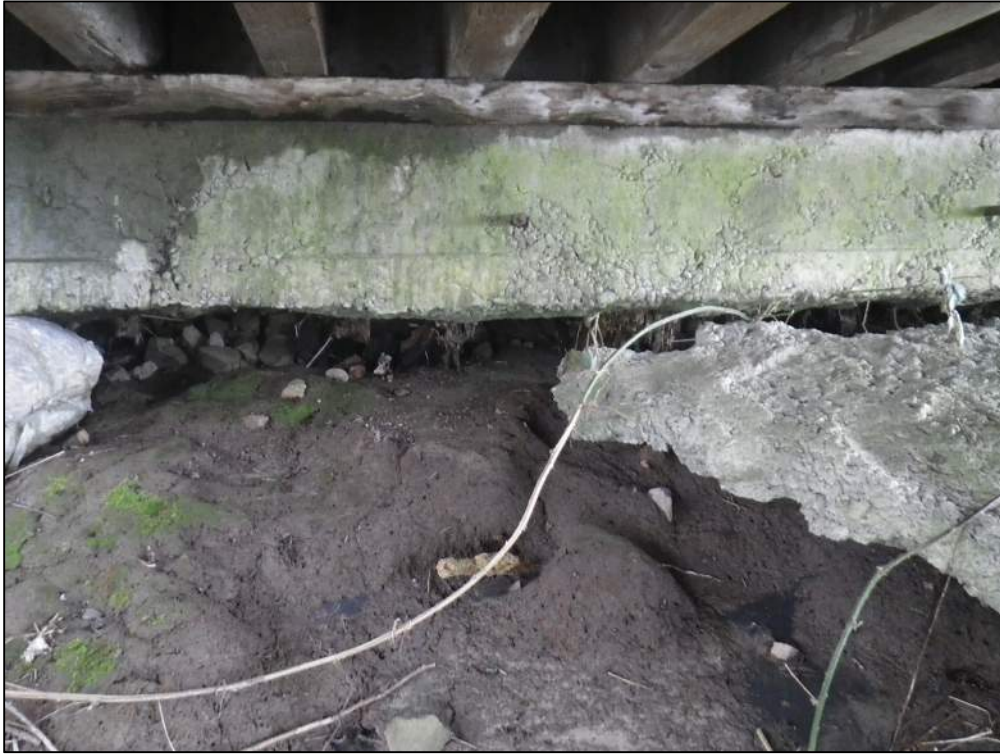
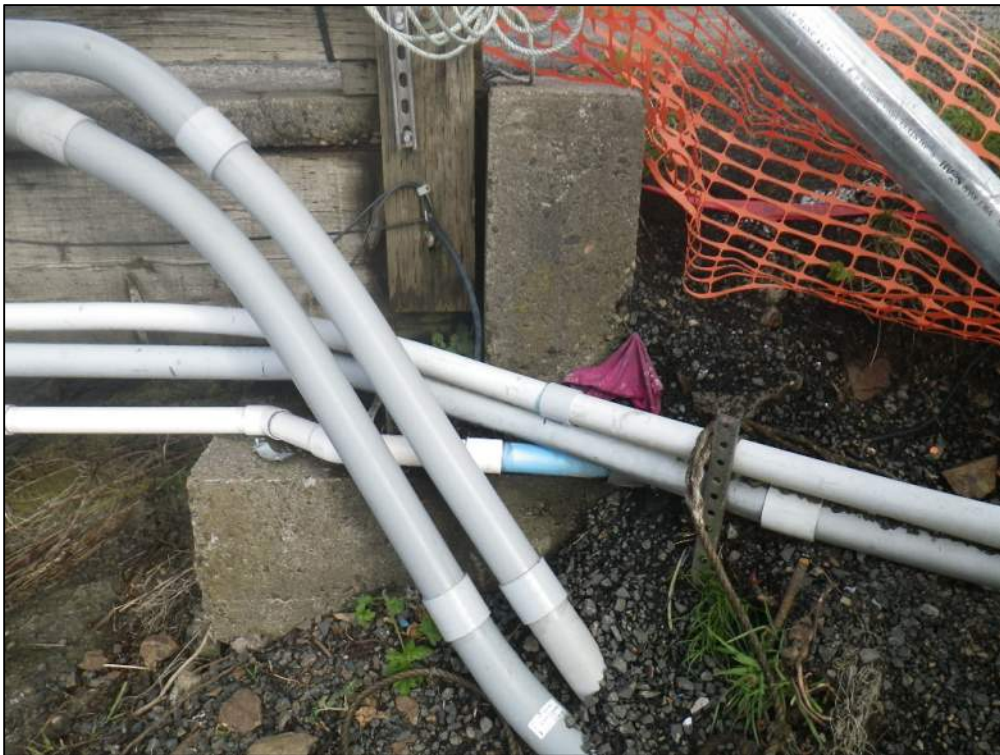
The west trestle abutment and abutment timber piles are assigned an element damage rating of “severe” because the abutment shows signs of advanced deterioration and overstressing caused by settlement of the abutment. The settlement of the abutment appears to be due to scour below the abutment likely leading to the accelerated decay of the supporting timber piles. The west trestle concrete deck exhibits major cracking and upward displacement near WT1. This upward displacement is due to settlement at the abutment causing the supporting deck beams to rotate and displace the deck upward near WT1. The deck between WT0 and WT2 is assigned a damage rating of “moderate” because of the cracking and spalling caused by the settlement of the abutment.

**Photo 6. West Trestle Abutment**

**Photo 7. West Trestle Abutment Scour And Timber Pile Decay**

**Photo 8. West Trestle Abutment Side View**

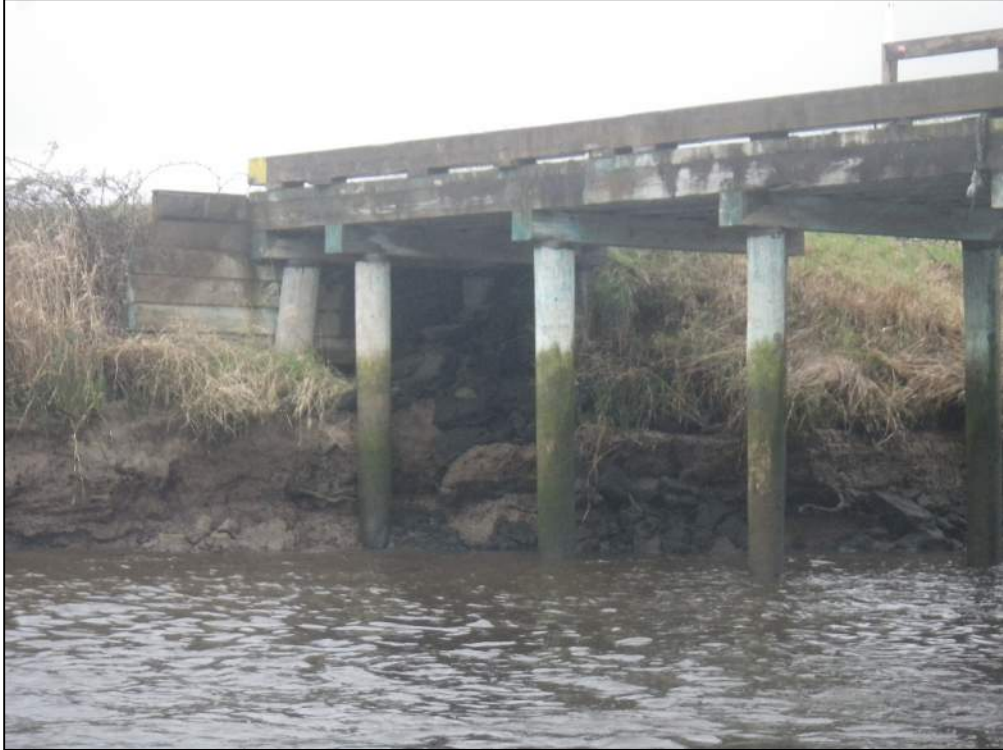
of structural distress was observed at the east trestle abutment. Photo 9 shows the east trestle abutment existing conditions.

**Photo 9. East Trestle Abutment**

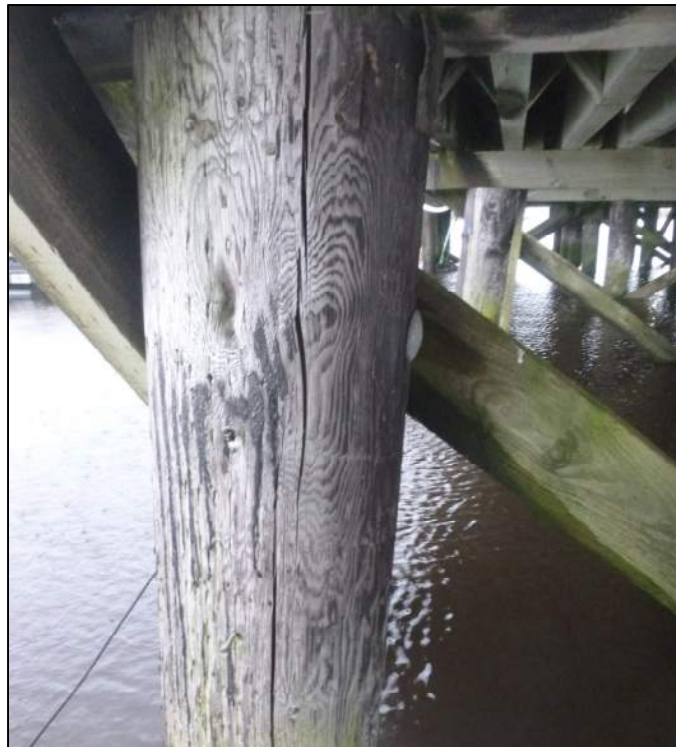
Approximately 24 timber piles have minor cracks near the top up to 1/2 inch wide by 4 feet long. See Photo 10 for typical crack near the pile top. Two timber-bearing piles have been displaced and do not provide bearing for the pile cap above. The displaced piles are located at bent WP13, pile row WPA; and at WP31, pile row WPD. See Photos 11 and 12 for displaced piles.

**Photo 10. Typical Pile Crack (Pile WT5/C)**

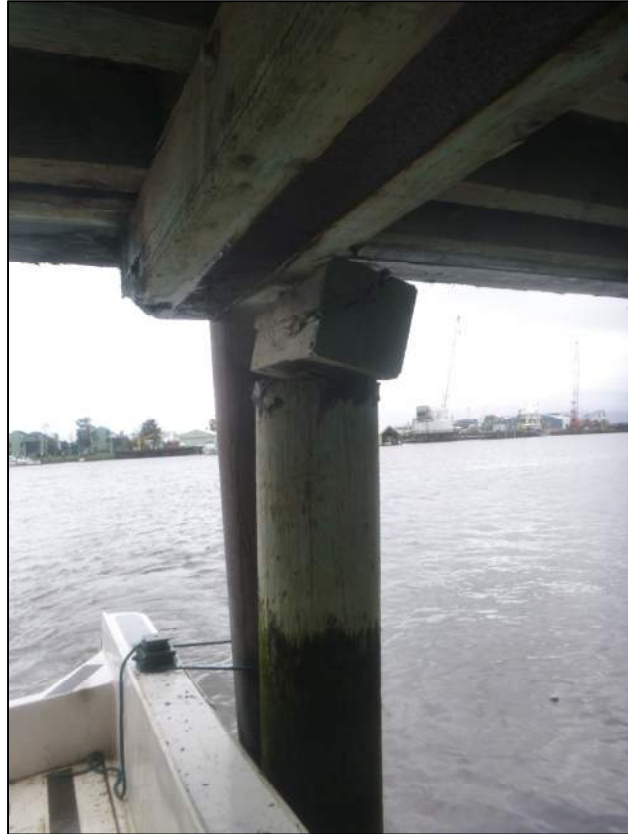
**Photo 11. Displaced Pile At WP13/A**

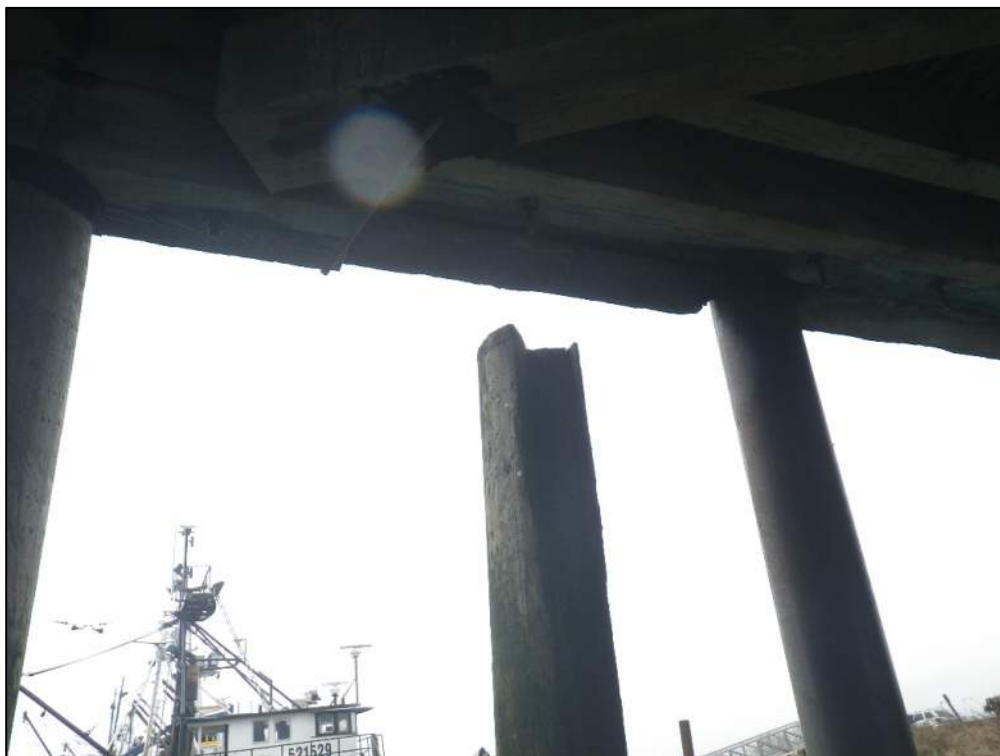
**Photo 12. Displaced Pile At WP31/D**

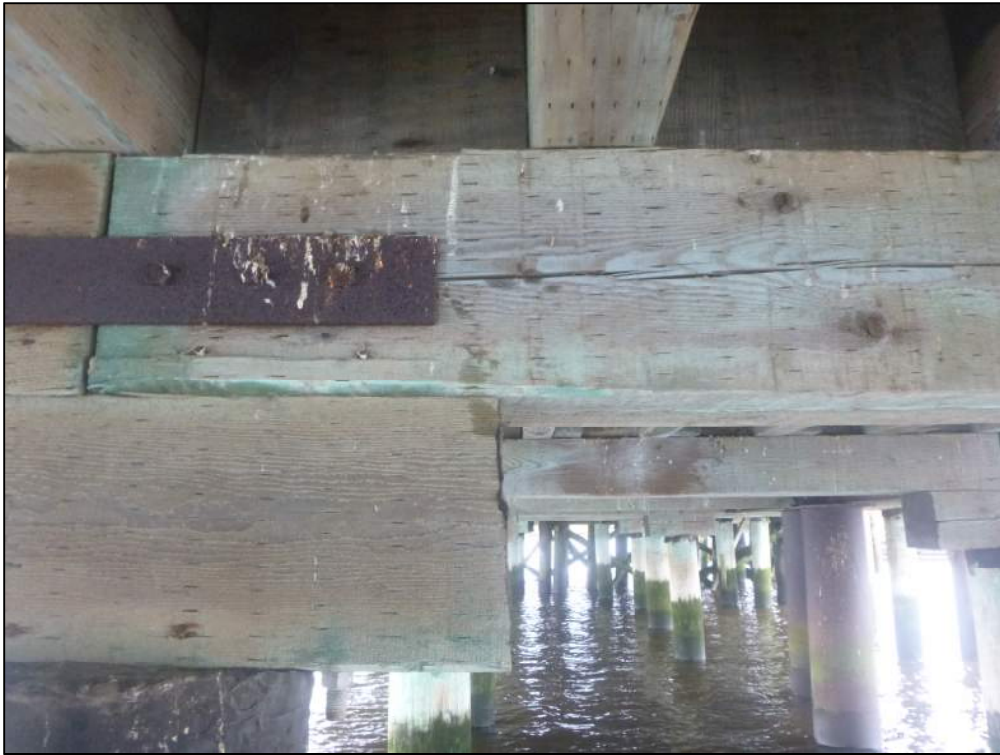
Approximately eight pile caps have minor cracks or splits on one side that are 3/8 inch wide or less. See Photo 13 for a typical pile cap crack. Wetness and decay approximately 2 inches deep by 6 inches long by 8 inches high was observed at the east end of pile cap WT7. Pile cap WT10 exhibits moderate to severe damage, including deformation of the pile cap from pile row WTB to WTD, broken pile cap near pile row WTE, and decay of pile cap cross section between 10 to 25 percent. See Photos 14 through 16 for the damage at pile cap WT10.

**Photo 13. Typical Pile Cap Split (Bent WP10)**

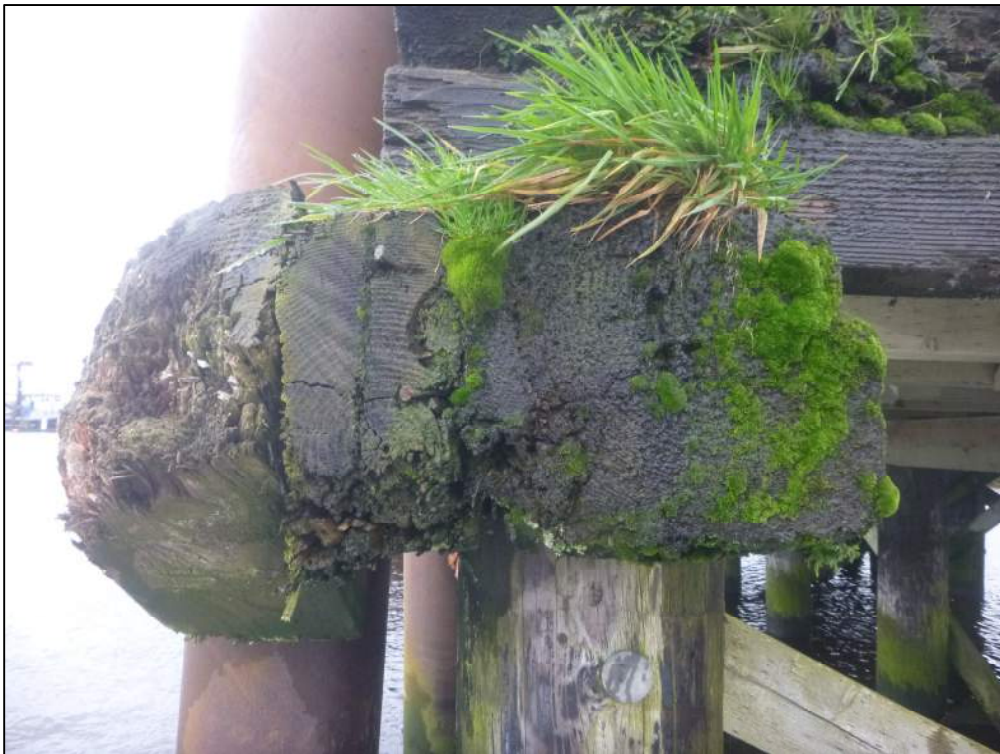
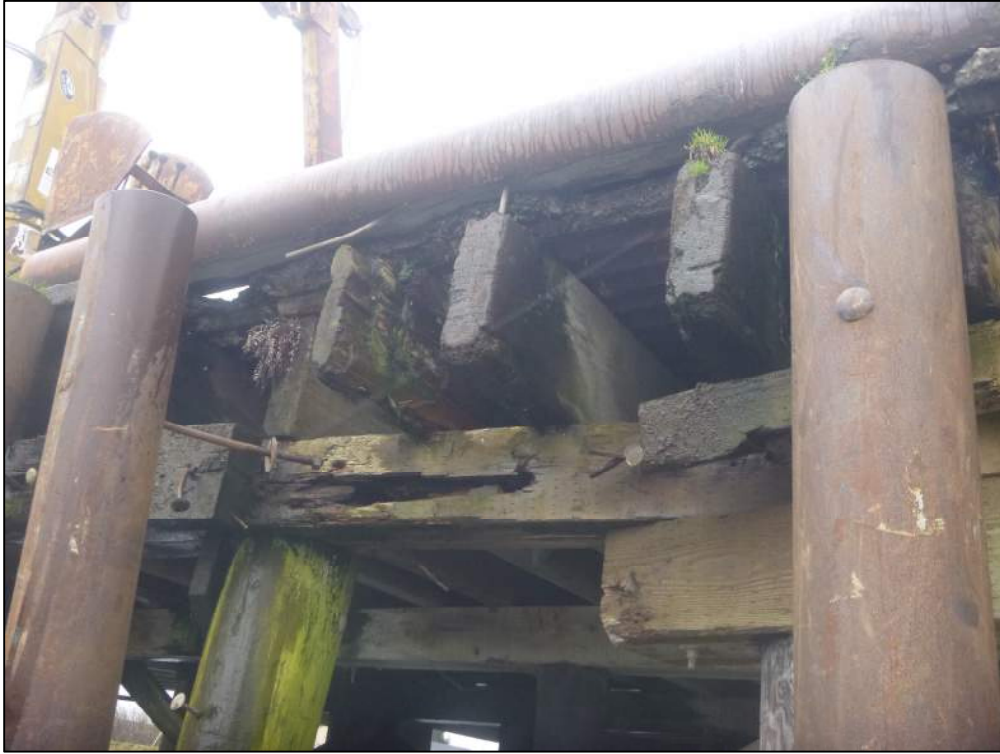
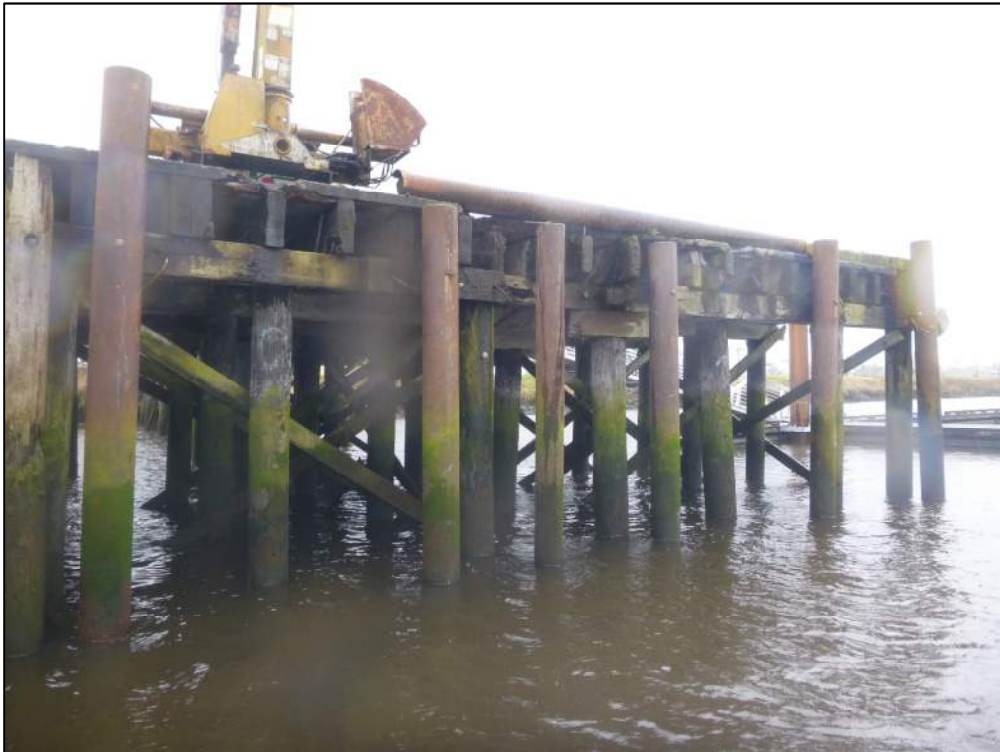
The concrete deck and timber elements near the north edge of the west trestle along pile cap WT10 are assigned element damage ratings of “moderate” to “severe” because advanced deterioration and overstressing was observed. The deterioration at the north edge of the west trestle includes a broken pile cap WT10, a displaced pile at WTC that is not providing bearing support, major decay at the north ends of the timber beams, concrete deck spalls at the deck edge, and metal decking below the concrete with major corrosion and section loss. Other areas of the concrete deck are assigned an element damage rating of “minor”; however, a large opening and three large gaps in the concrete deck are allowing water to leak onto the timber framing elements below, which is causing accelerated deterioration of those timber elements.

**Photo 14. West Trestle Pile Cap Decay At Pile WT10/A**

**Photo 15. West Trestle Pile Cap Decay At Bent WT10**

**Photo 16. West Trestle Pile Cap Decay At Bent WT10**

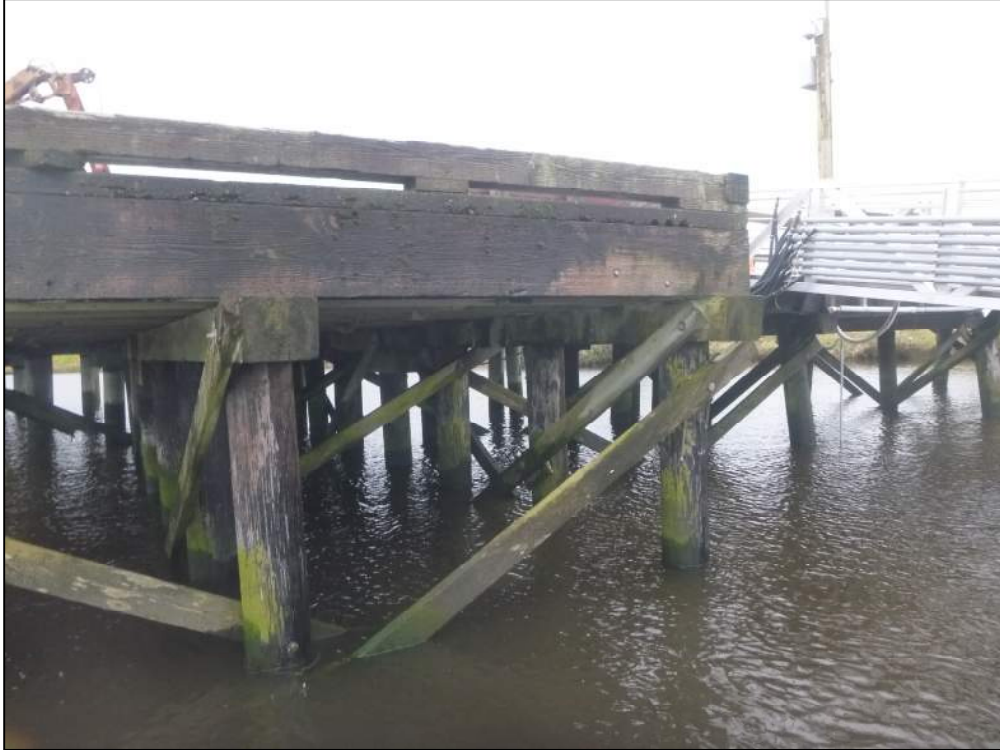
Three diagonal braces at the west trestle were observed to be broken. The location of the broken braces are at pile WT5/C, WT10/E, and WT10/G. Moderate decay up to 25 percent was observed near the top connection of the diagonal brace at pile WT10/G. Typical bracing can be seen in Photo 17.

**Photo 17. West Trestle Typical Bracing**

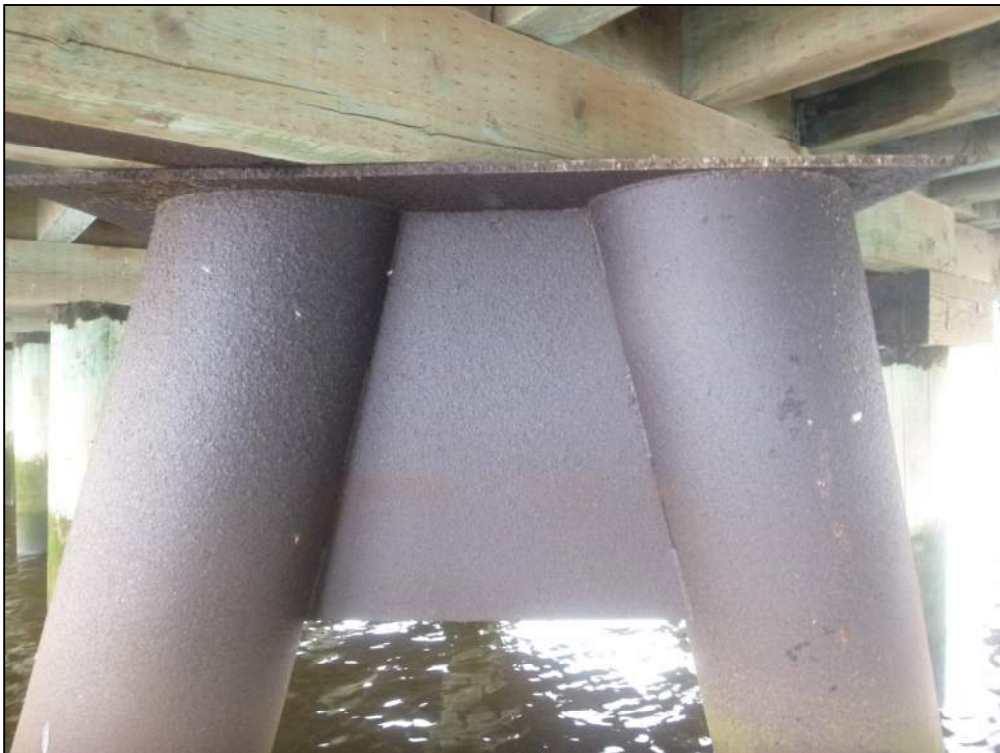
The steel battered pile pairs exhibit surface corrosion but no section loss. A typical battered pile pair can be seen in Photo 18.

**Photo 18. Typical Steel Battered Pile Pair (Bent WP13)**

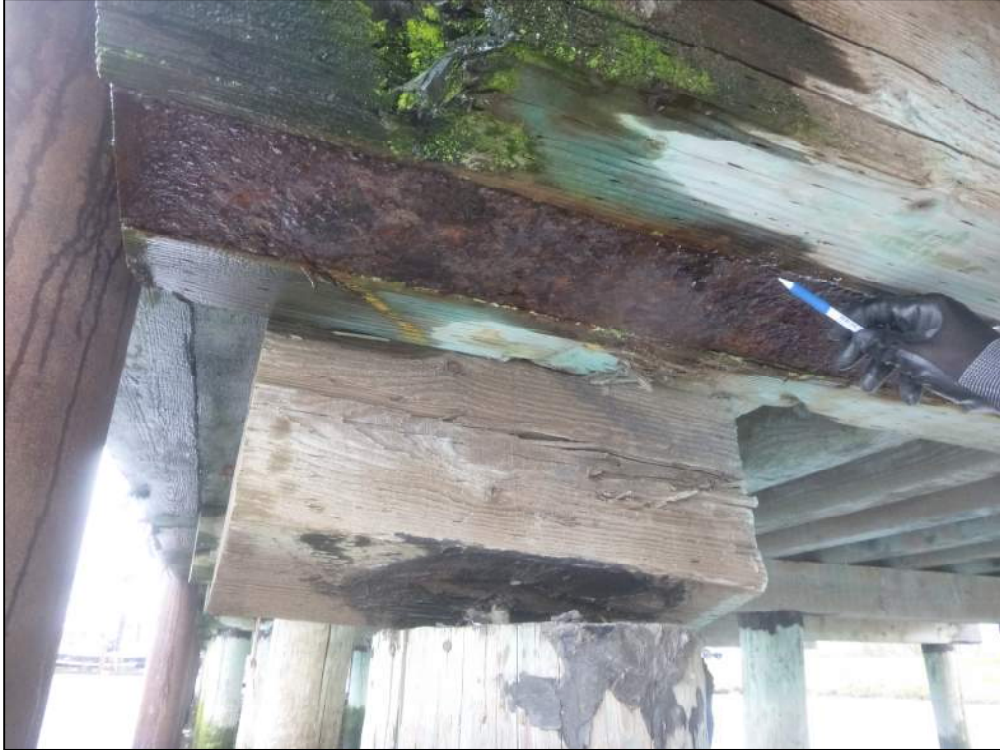
Steel pile caps at WP27 and WP13 exhibit corrosion at the bottom flange with flaking steel and measurable section loss. The section loss at the bottom flange is considered minor. Typical corrosion at the bottom of the steel pile cap is shown in Photo 19.

**Photo 19. Typical Steel Beam Corrosion (Bent WP13)**

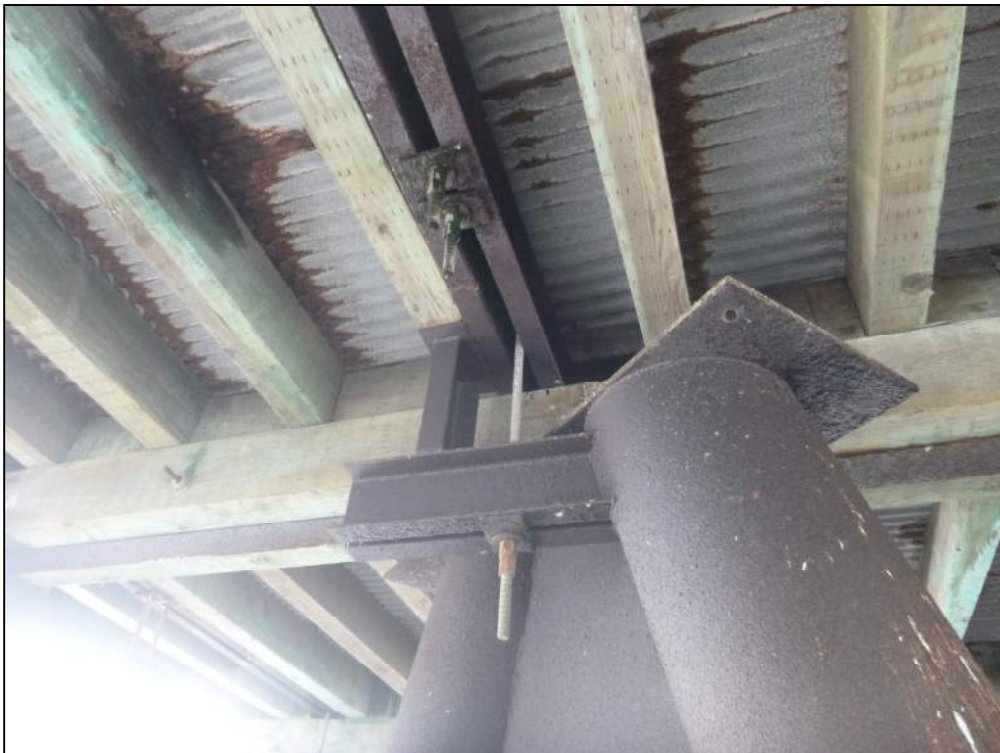
Miscellaneous steel beams near WP12 and WP14, as well as at WP26 and WP28, exhibit minor surface corrosion. See Photo 20 for typical corrosion at miscellaneous steel beams.

**Photo 20. Typical Corrosion At Miscellaneous Steel Beams (Bent WP27)**

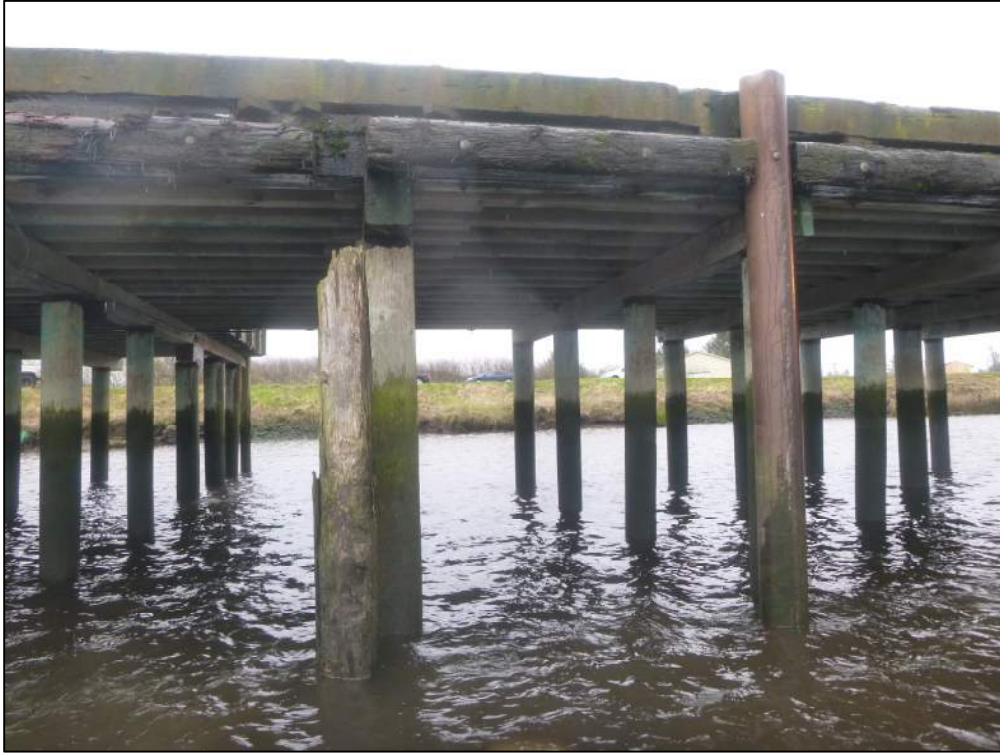
A majority of the steel fender piles exhibit minor surface corrosion but no section loss. Photo 21 shows typical surface corrosion of fender piles. Four steel fender piles at bent WT10 exhibit moderate damage of a bent or broken connection at the top bolt into the timber pile cap. Typical broken or bent connection is shown in Photo 15. Steel fender piles at bent WP27 and WP29 exhibited small dents approximately 1 inch deep by 8 inches long.

Broken timber piles were observed at eight locations: WP12D, WP14, WP18, WP19D, WP25, WP26D, WP32B, WP32D.5, ET5, and ET6.5. A typical broken timber pile can be seen in Photo 21.

**Photo 21. Typical Fender Pile Corrosion And Broken Timber Pile (Bent WP24/25)**

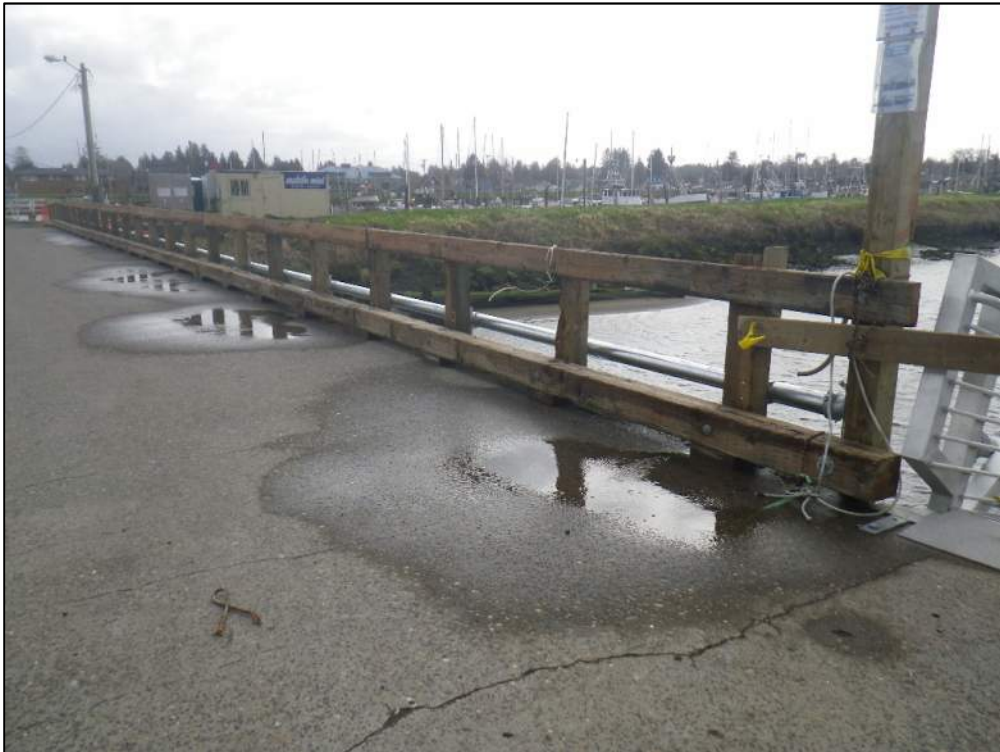
The west trestle concrete deck exhibits moderate cracks up to 1/16 inch wide at a density between 4 to 6 feet on center spacing. The deck between WT0 and WT2 has major cracks up to 3/16 inch wide at a density of 2 to 3 feet on center spacing. Spalls and delamination over 1 inch deep for approximately 10 percent of the deck surface was present between WT0 and WT2. The deck over the abutment at WT0 has displaced downward and the deck near WT1 has displaced approximately 3 inches upward. Gaps at deck construction joints are present along bents WT8, WP1, and WP3. The gaps range from 1/2 inch wide up to 2 3/8 inches wide. A concrete spall near the intersection of bent WT8 and WP1 is the full depth of the deck and approximately 9 inches wide by 9 inches long. A steel drift pin extends up through the deck at this spall location. The north edge of the concrete deck along WT10 has spalls and missing chunks of concrete below the bullrail. Approximately 40 square feet of the concrete deck has been removed and replaced with timber boards and steel plates along bent WT8 between pile rows WTE and WTG.

**Photo 22. West Trestle Typical Deck Cracks**

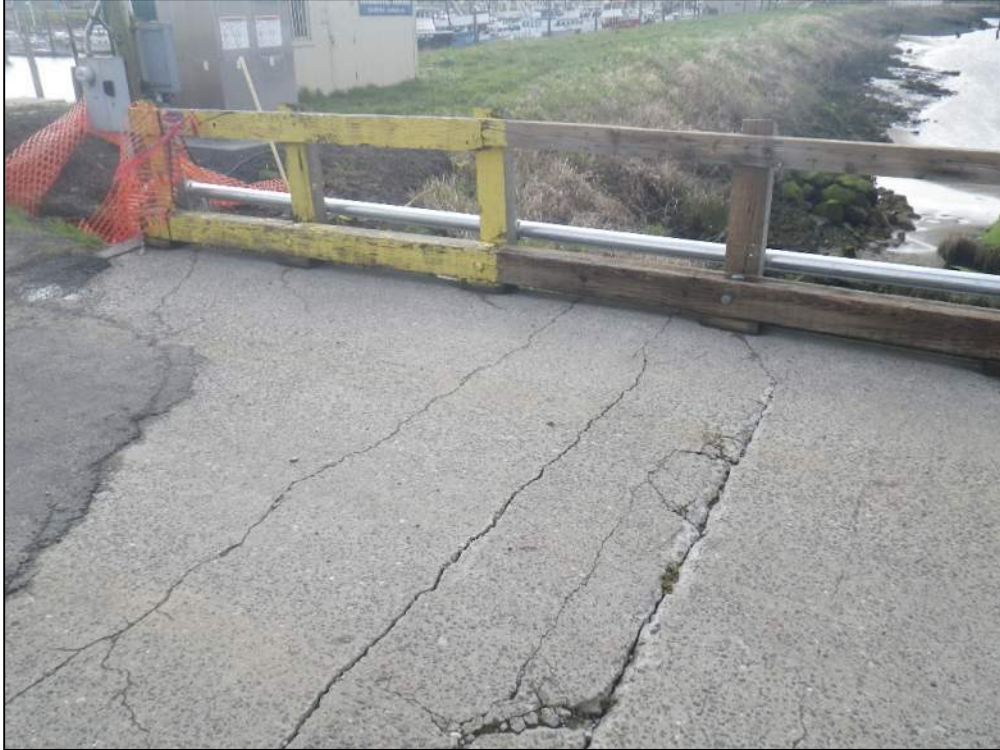
**Photo 23. West Trestle Cracks And Spalls Between WT0 And WT2**

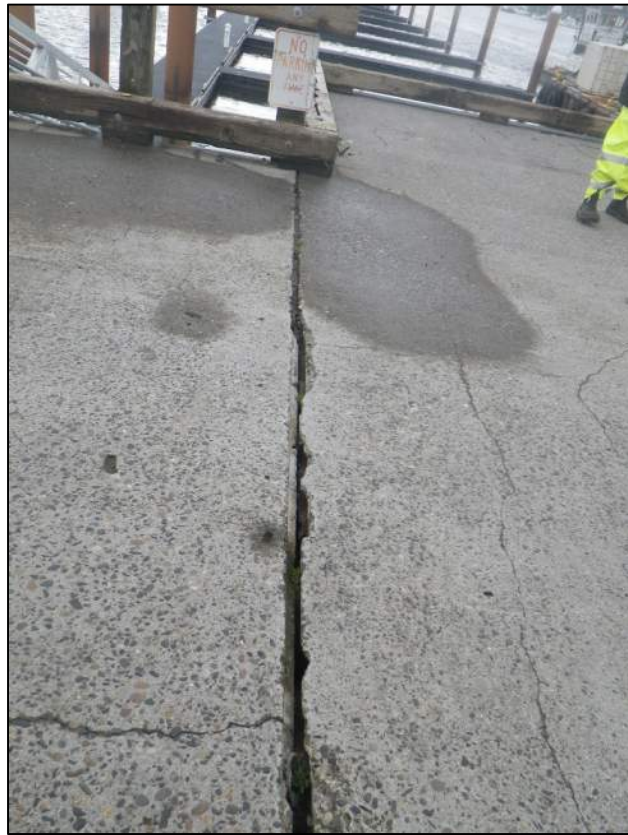
**Photo 24. West Trestle Gap In Deck At WT8**

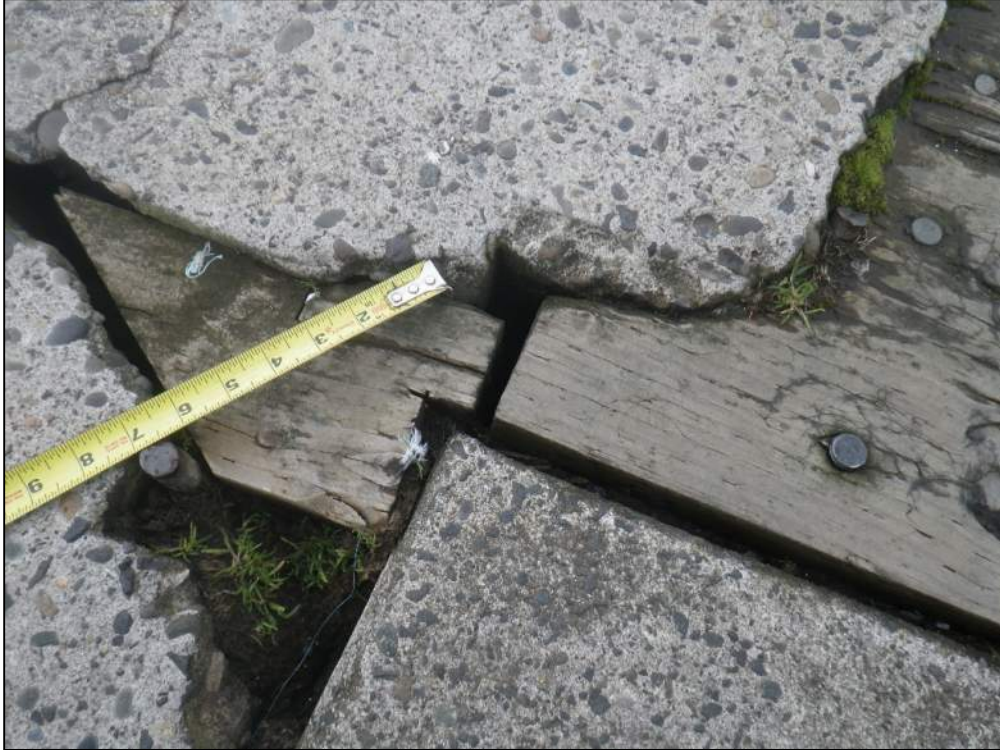
**Photo 25. West Trestle Spall In Deck At WT8**

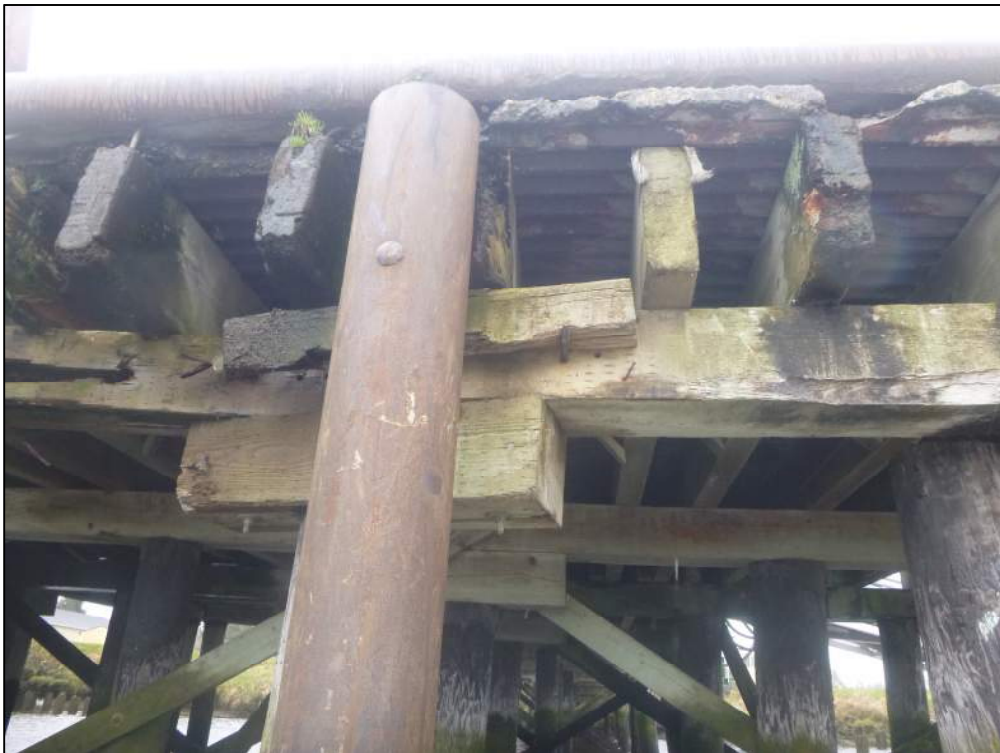
**Photo 26. West Trestle Deck Edge Spalls And Metal Deck Corrosion At WT10**

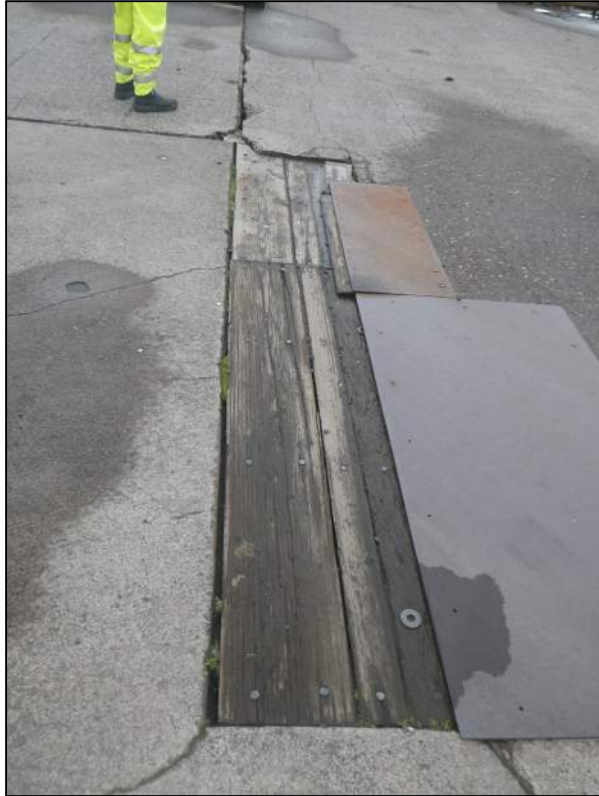
**Photo 27. West Trestle Removed Deck At WT8**

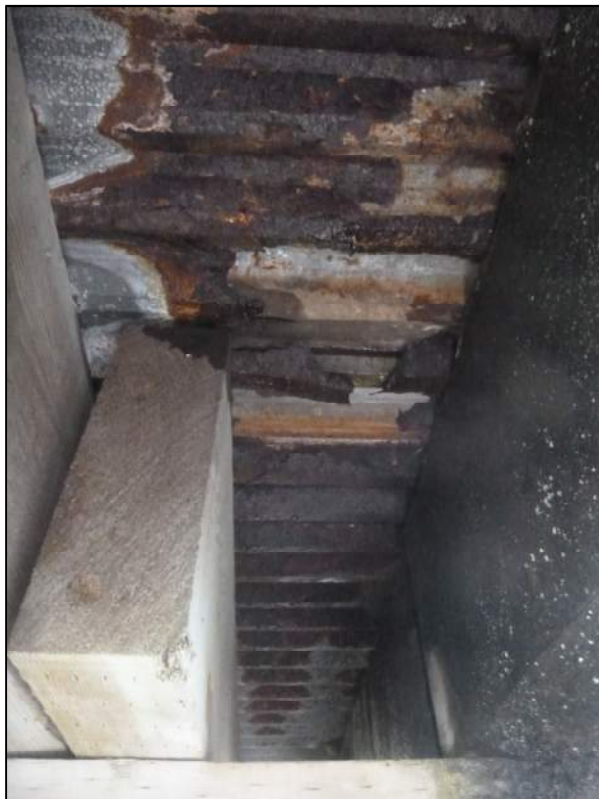
side of the trestle near WT4, an approximate area of 2 square feet exhibits major section loss of the metal deck and the concrete surface is exposed. The metal decking at the interior of the west trestle typically has isolated areas of rusting over about 10 percent of the metal decking surface area. At the north edge of the trestle along WT10, the metal decking exhibits active corrosion within 2 feet of the deck edge and major section loss up to 100 percent was observed near the metal decking edge below the bullrail. Photos 22 through 28 show damage of the concrete deck and metal decking at the west trestle.

**Photo 28. West Trestle Steel Deck Corrosion And Section Loss At Bent WT4**

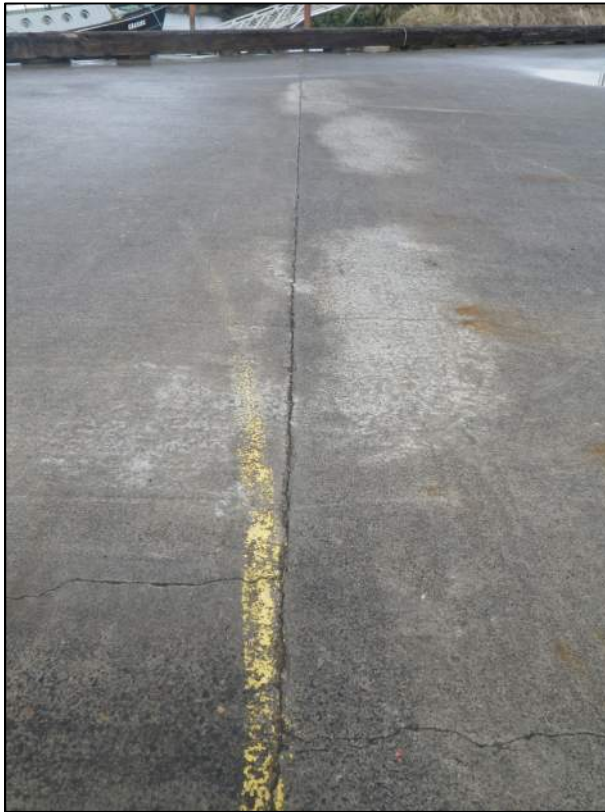
The work pier concrete deck exhibits minor cracks up to 1/16 inch wide at a density between 5 to 12 feet on center spacing. Minor concrete chips were typically present along the concrete deck construction joints throughout the work pier. A small spall 1/2 inch deep by 2 inches wide by 3 inches long was present at the construction joint intersection with bent WP29. A small spall 1 inch deep by 3 inches wide by 8 inches long was present at the construction joint intersection with bent WP21. Below the concrete deck, approximately 10 percent of the metal decking surface area exhibits isolated areas of rusting. Photos 29 and 30 show damage of the concrete deck and metal decking at the work pier.

**Photo 29. Work Pier Typical Construction Joint And Cracks (Pile Row WPD Looking West)**

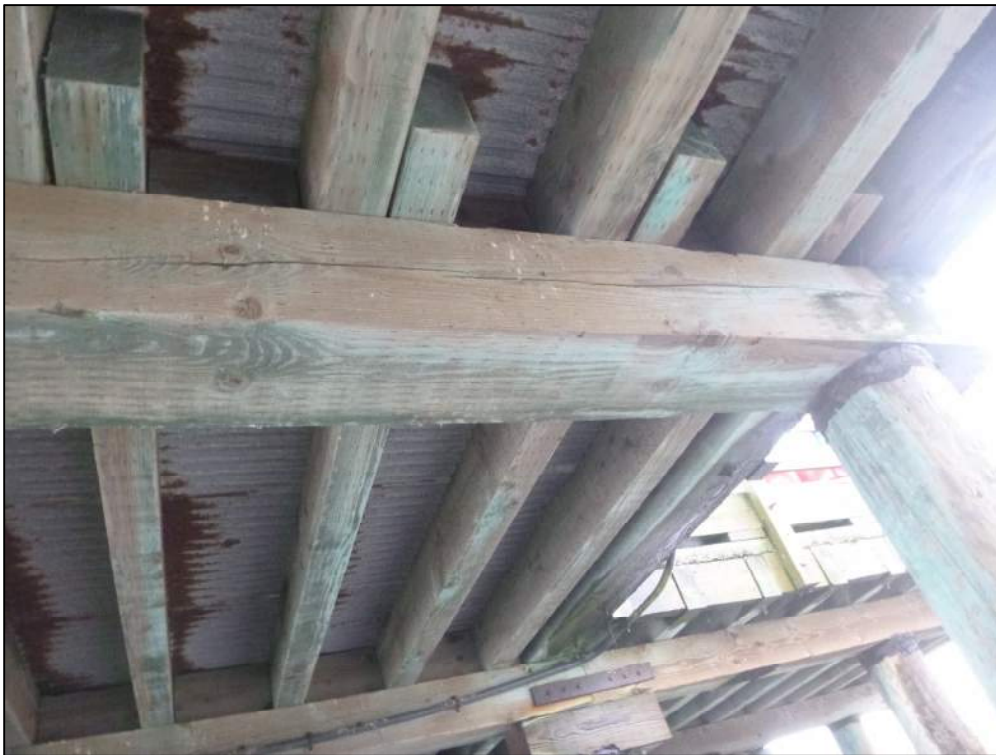
**Photo 30. Work Pier Typical Deck Corrosion (Bent WP25)**

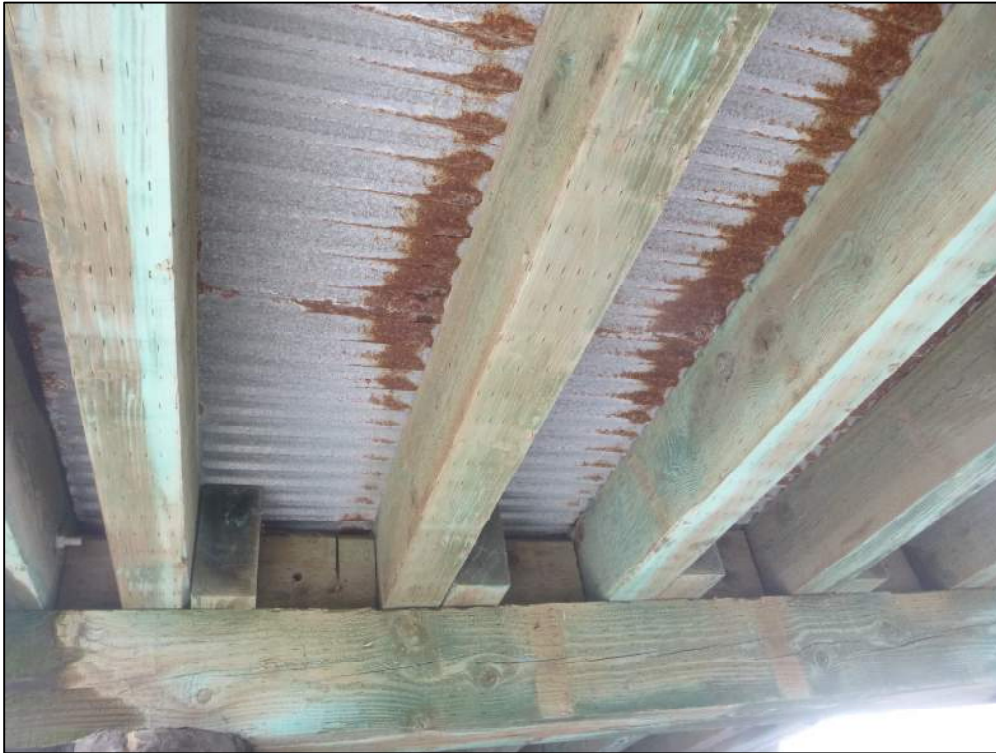
The east trestle concrete deck typically exhibits insignificant cracks less than 1/32-inch wide at a density of approximately 10 feet on center spacing. A general crack 1/16 inch wide by 9 feet long is present along ET4. Below the concrete deck, approximately 10 percent of the metal decking surface area exhibits isolated areas of rusting. Photo 31 shows typical metal decking corrosion at the east trestle.

**Photo 31. East Trestle Typical Deck Corrosion (Bent ET5)**

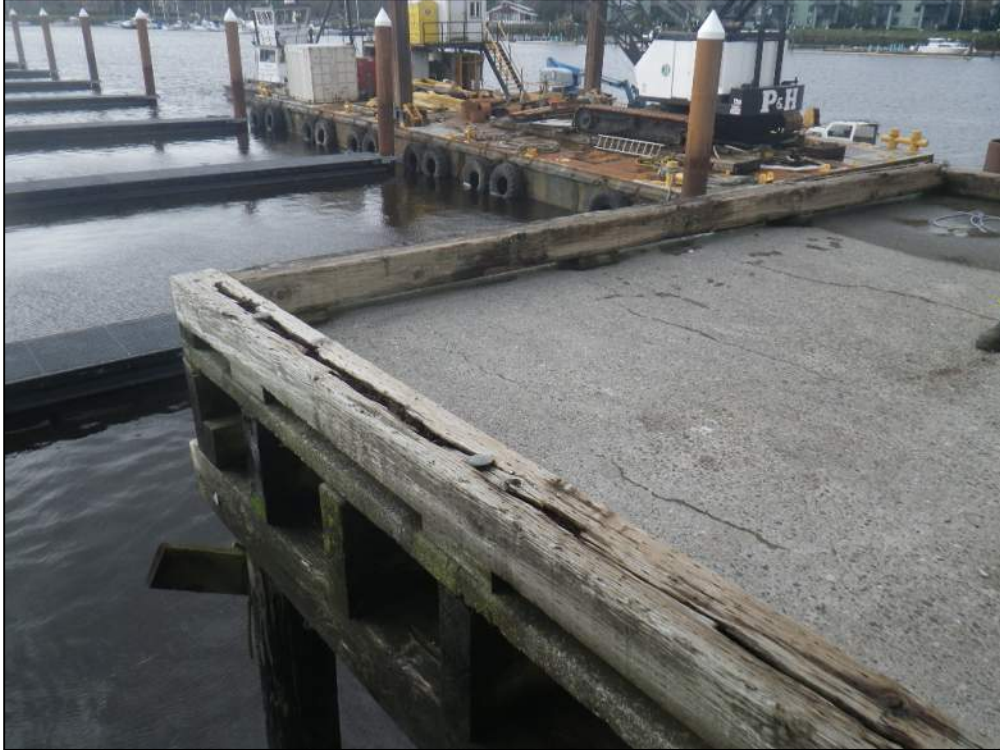
The timber bullrail each side of the west trestle from WT0 to WT8 exhibited minor cracks in the top of the bullrail up to 1/16 inch wide by approximately half the length of the bullrails. Approximately 33 linear feet of bullrail at the west trestle along WT8 and WTA exhibit major to severe decay with section loss from 25 percent to greater than 50 percent. About 6 linear feet of bullrail is missing along WT10 between WTF and WTG. Approximately 20 linear feet of bullrail at WT10 has a modified steel pipe placed over the timber bullrail. The steel pipe does not appear to be positively attached to the deck. At the work pier, the bullrail along the riverside typically has minor rounding of the corners. A missing bullrail support block was observed at the riverside bullrail near bent WP5. An approximately 10-foot-long segment of the east trestle bullrail, along pile row ETB, has a broken connection and is displaced between ET0 and ET0.5.

**Photo 33. West Trestle Bullrail Decay At Bent WT8**

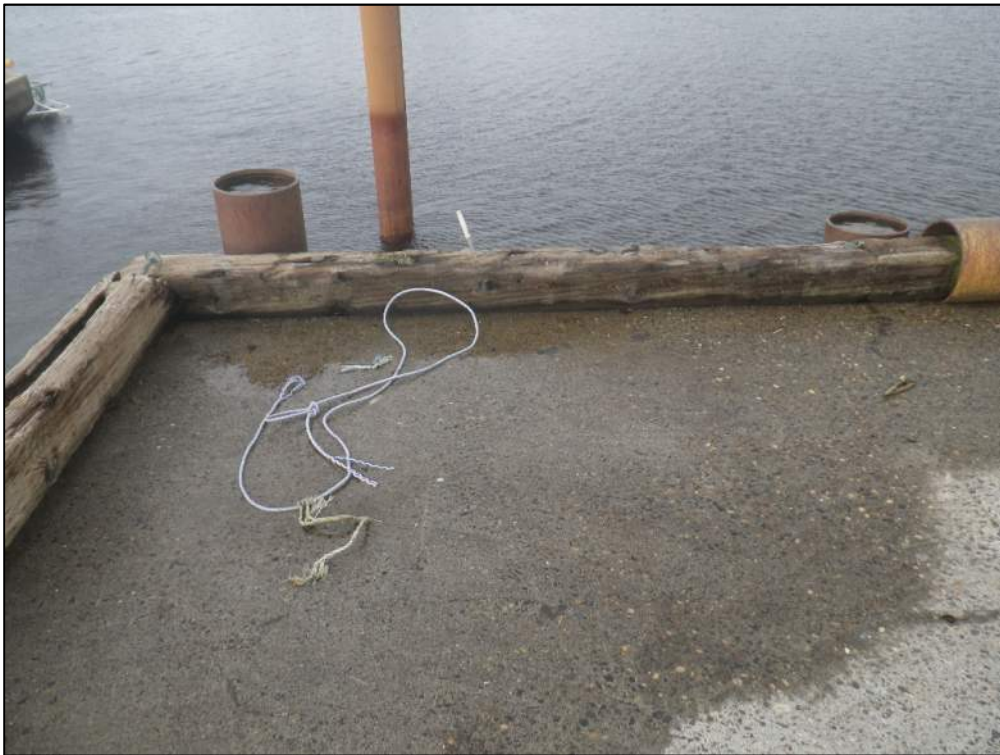
**Photo 34. West Trestle Bullrail Deterioration At Bent WT10**

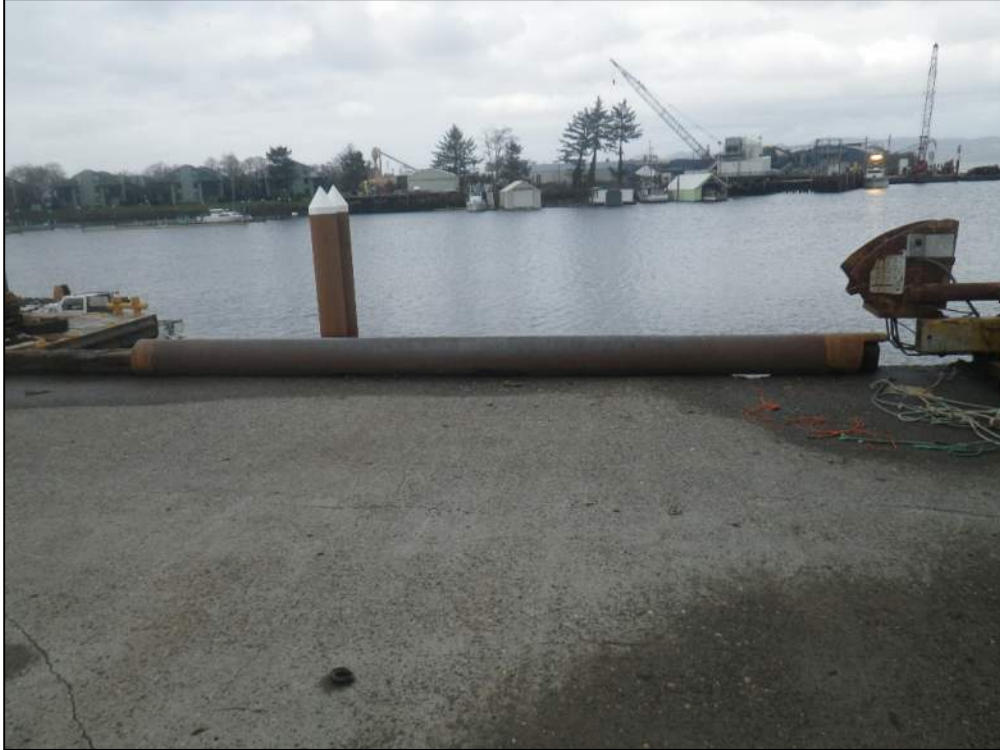
**Photo 35. West Trestle Steel Bullrail At Bent WT10**
