# Condition Survey and Load Rating Report – FINAL

**City of Warrenton  
Warrenton Marina Work Pier**

**July 2017**

**BergerABAM  
700 NE Multnomah St, Suite 500  
Portland, OR 97233**

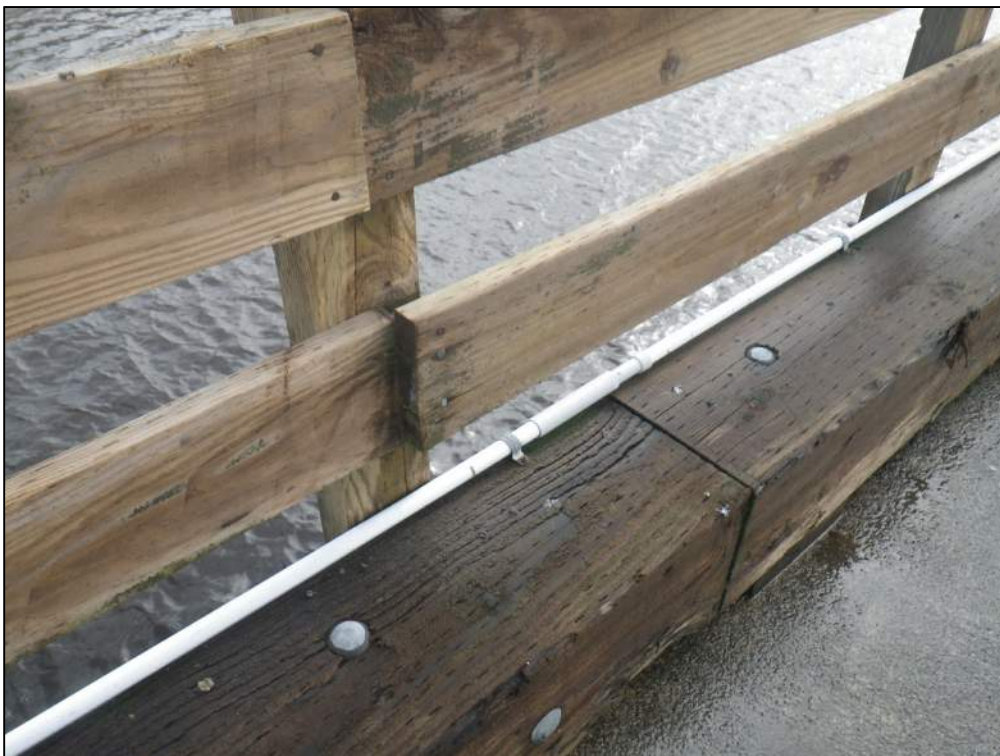
The timber railing elements and connections to the pier exhibited no defects, with the exception of one location with a loose horizontal mid-rail connection at WP28. The railing along the east

**Photo 38. Work Pier Loose Connection At Horizontal Rail At WP28**

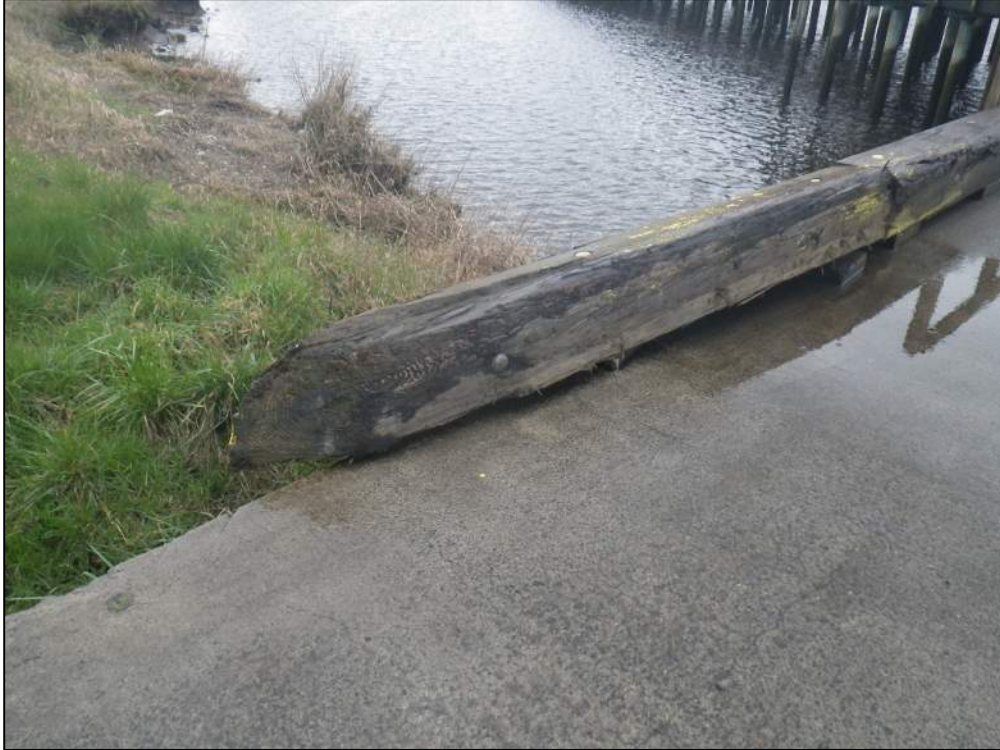
The timber bullrail each side of the west trestle from WT0 to WT8 exhibited minor cracks in the top of the bullrail up to 1/16 inch wide by approximately half the length of the bullrails. Approximately 33 linear feet of bullrail at the west trestle along WT8 and WTA exhibit major to severe decay with section loss from 25 percent to greater than 50 percent. About 6 linear feet of bullrail is missing along WT10 between WTF and WTG. Approximately 20 linear feet of bullrail at WT10 has a modified steel pipe placed over the timber bullrail. The steel pipe does not appear to be positively attached to the deck. At the work pier, the bullrail along the riverside typically has minor rounding of the corners. A missing bullrail support block was observed at the riverside bullrail near bent WP5. An approximately 10-foot-long segment of the east trestle bullrail, along pile row ETB, has a broken connection and is displaced between ET0 and ET0.5.

**Photo 39. East Trestle Displaced Bullrail (Bent ET0 to ET0.5)**

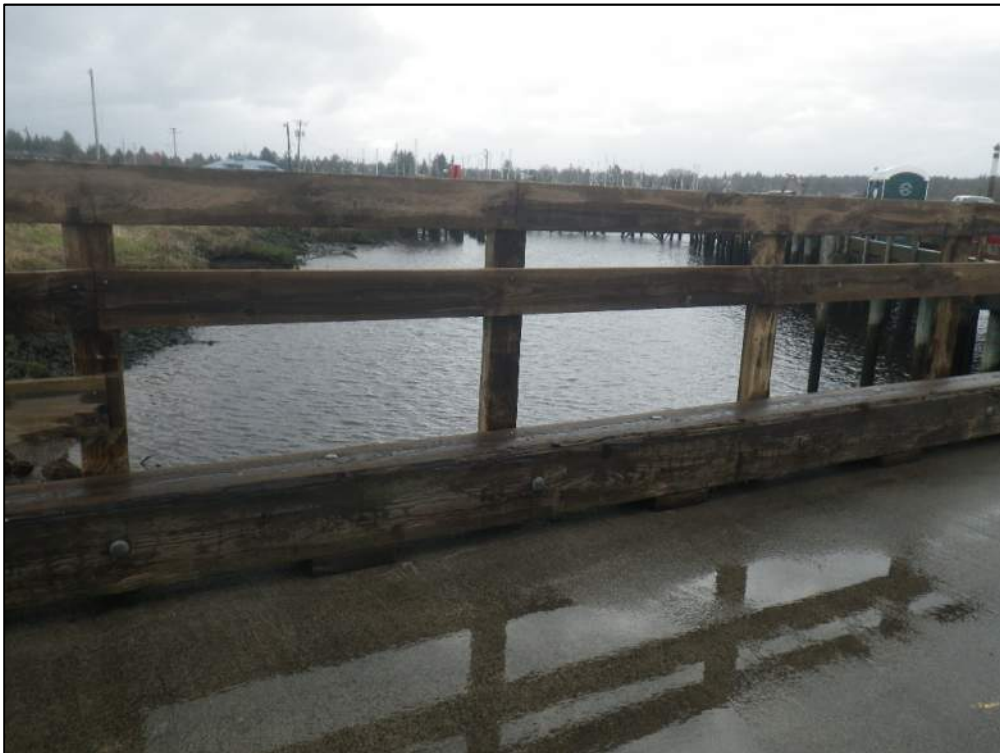
trestle and the work pier appears to be of newer construction than the railing along the west trestle. The east trestle and work pier railing typically has three horizontal rails; however, the lower horizontal rail is missing between ET1 to ET2 and between ET3 to ET6. The full length of the west trestle railing is only constructed with a top rail only and does not have a mid-rail or lower rail.

**Photo 40. East Trestle Railing Missing Bottom Rail (Bent ET3 to ET6)**
