# Condition Survey and Load Rating Report – FINAL

**City of Warrenton  
Warrenton Marina Work Pier**

**July 2017**

**BergerABAM  
700 NE Multnomah St, Suite 500  
Portland, OR 97233**

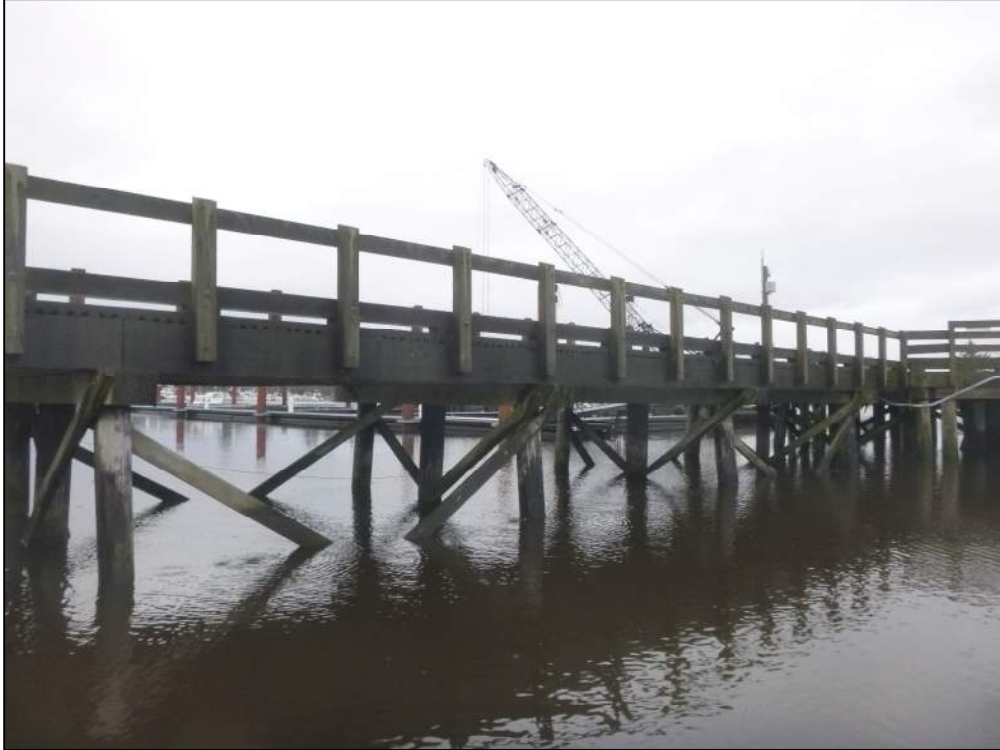
**Photo 1. West Trestle Looking Northwest**

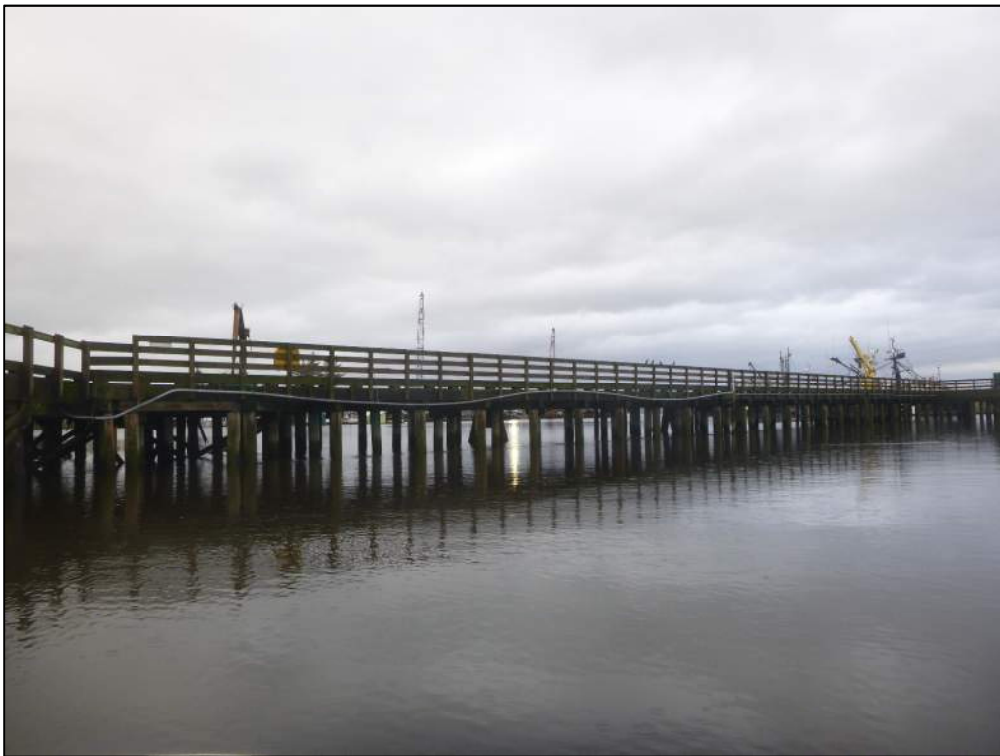
**Photo 2. Work Pier Looking North**

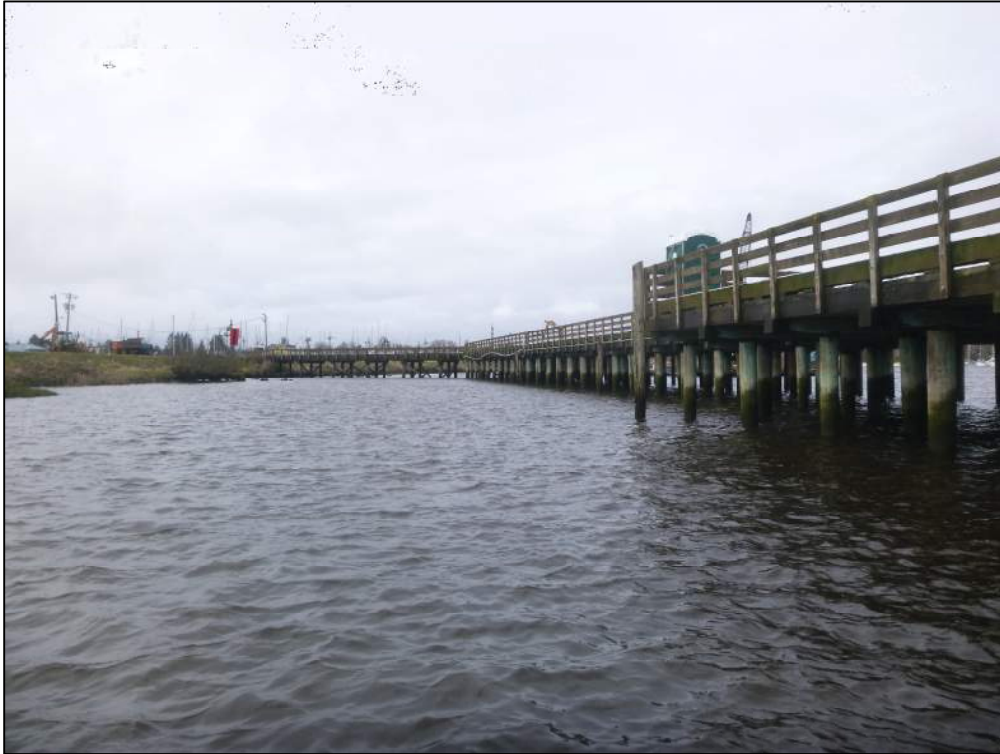
**Photo 3. Work Pier (Shore Side) Looking West**

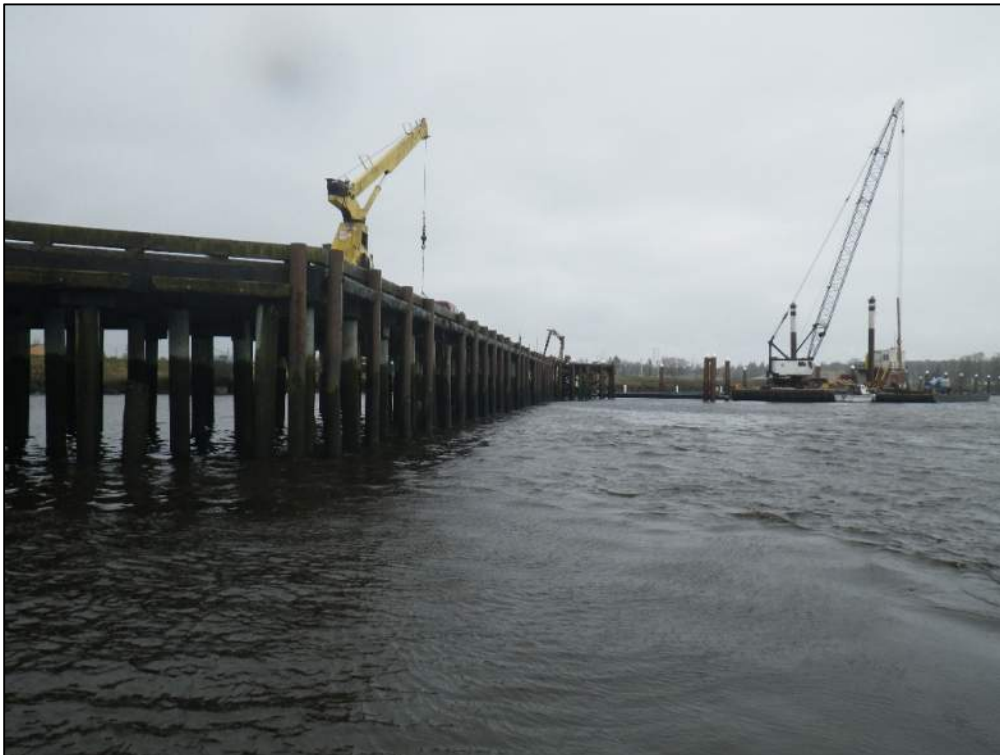
**Photo 4. Work Pier (River Side) Looking West**

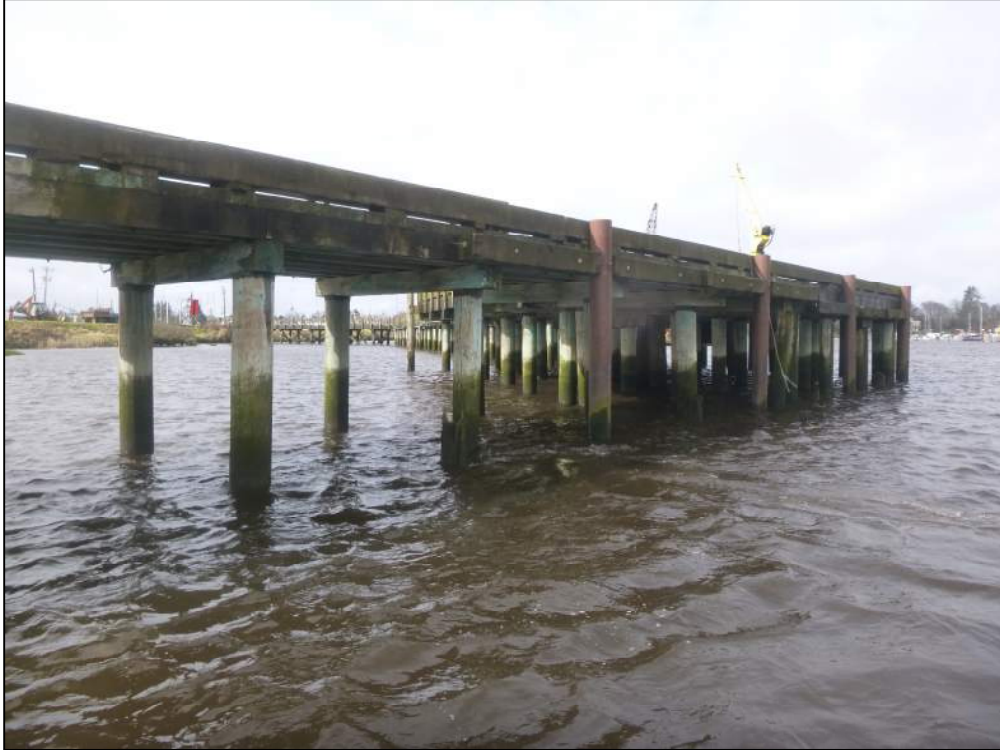
**Photo 5. East Trestle Looking West**

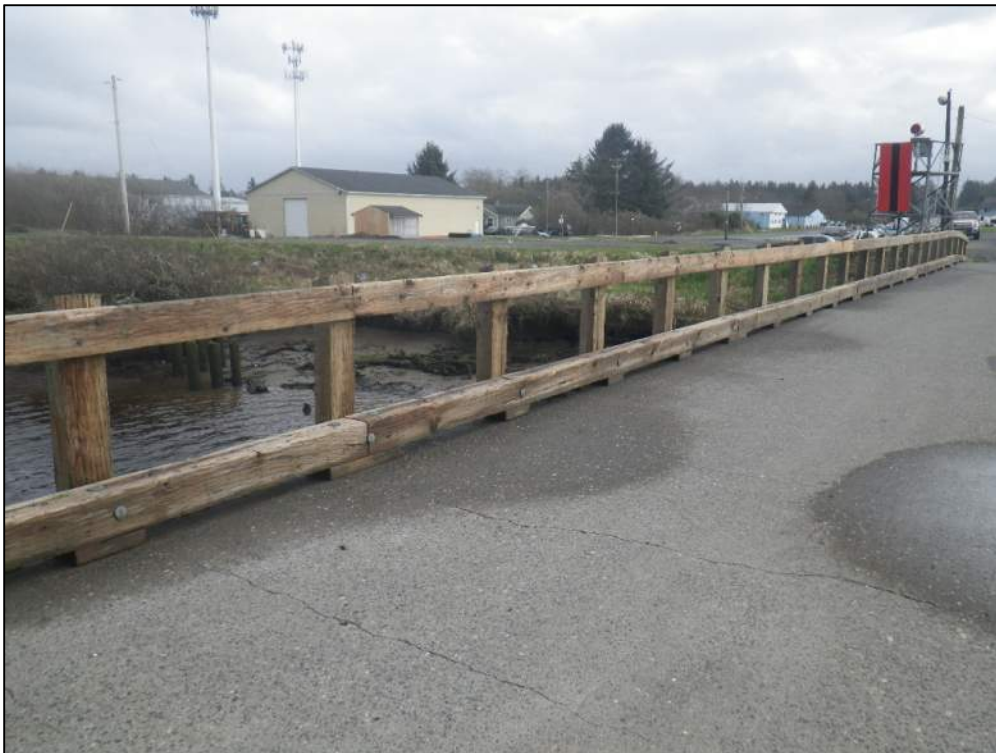
Photos 32 to 40 show typical bullrail and railing conditions and damage.

**Photo 32. West Trestle Typical Railing And Bullrail**

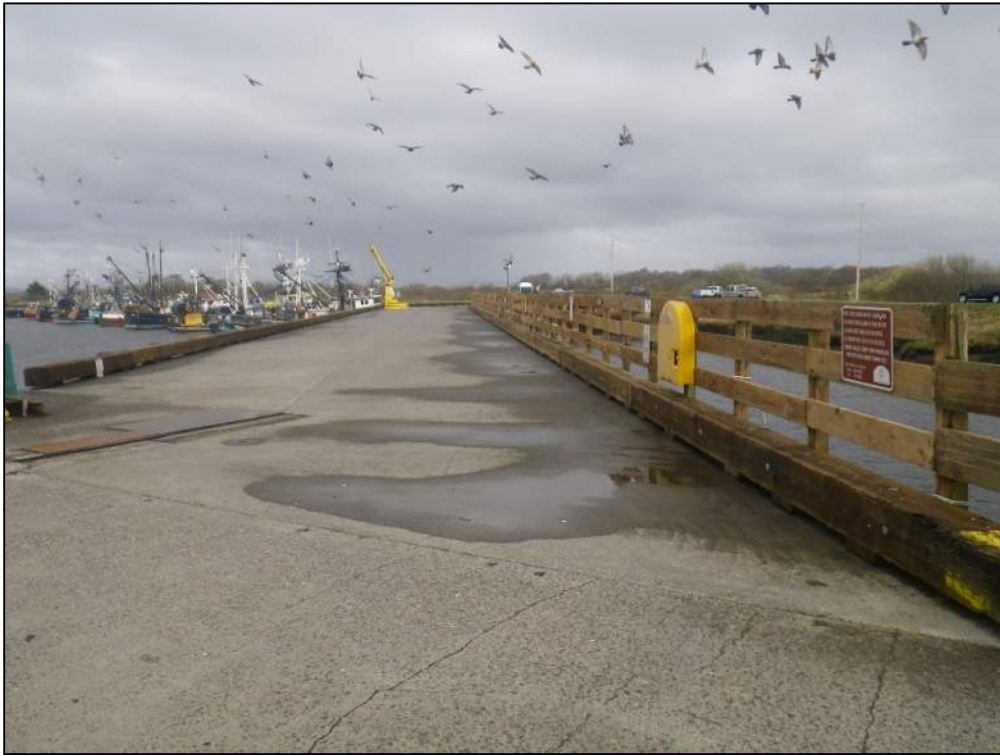
**Photo 37. Work Pier Typical Railing And Bullrail**
