# Condition Survey and Load Rating Report – FINAL

**City of Warrenton  
Warrenton Marina Work Pier**

**July 2017**

**BergerABAM  
700 NE Multnomah St, Suite 500  
Portland, OR 97233**

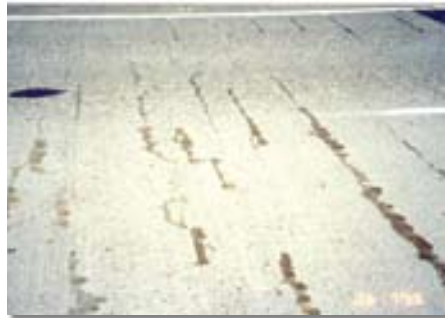
CS 1

1. The surface of the deck is cracked, but the cracks are either filled/sealed or insignificant in size and density to warrant repair activities.
2. Unsealed cracks exist in the deck that are of moderate size (0.025 to 0.060 in. wide) or density (3' to 10' apart).
3. Unsealed cracks exist in the deck that are of moderate size (0.025 to 0.060 in. wide) and density (3' to 10' apart).
4. Unsealed cracks exist in the deck that are of severe size (>0.060 in. wide) and/or density (<3' apart).
